# Facilities Condition Report

Allen Park Buildings

February 22, 2023  
(Revised August 10, 2023)

GSBS Architects  
&  
ARW Engineers

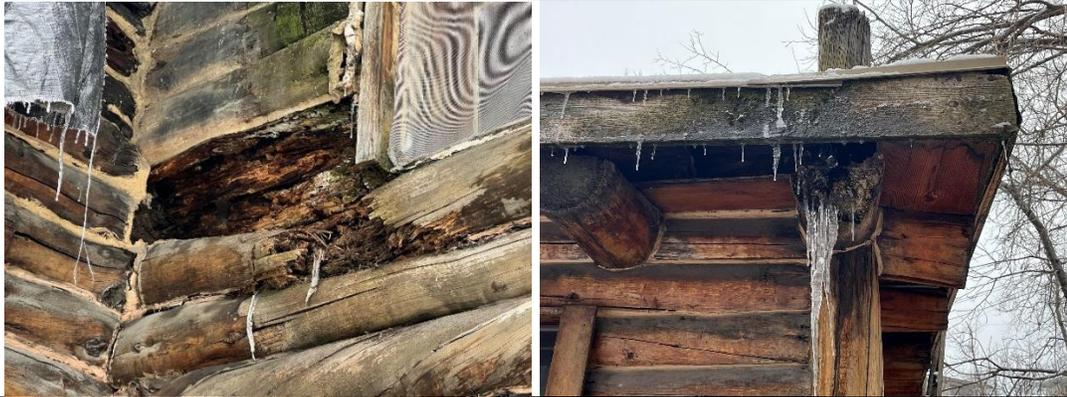
1.A.1-2

ITEM	DEFICIENCIES	PHOTOS	SHORT-TERM REPAIRS (0-5 Years)	LONG-TERM REPAIRS (25 Years)
1.A	Deteriorating logs at walls and roof eaves	1.A.1-3	Cover hole with EPDM membrane. Secure to sound logs.	Remove and replace deteriorating logs

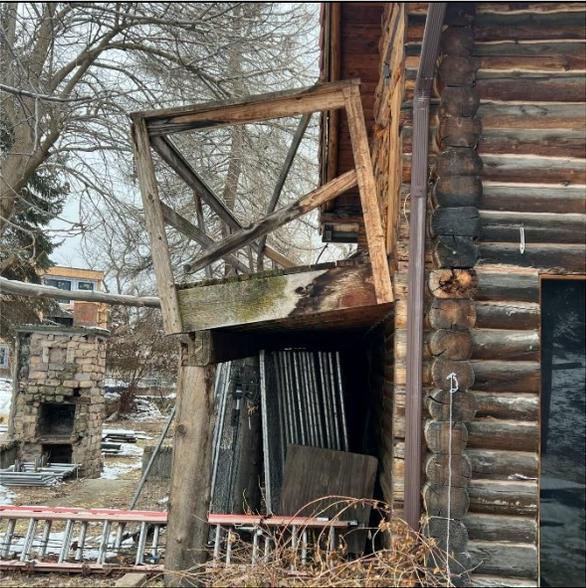
1.B	Sagging balcony at south side	1.B.1	Restrict access to balcony. Provide temporary shoring.	Shore with new footings and posts. Replace damaged, rotten wood and structural attachments.

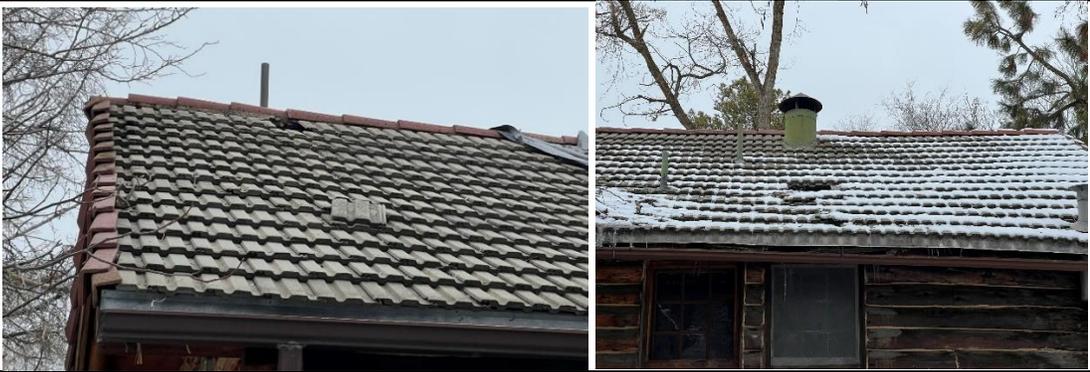
1.C	Holes in roof allowing rain and snow to enter building	1.C.1-2	Remove and salvage concrete roof tiles. Install ½" plywood sheathing on roof and SBS self-adhering granule-surfaced modified-bitumen rolled roofing membrane	Replace damaged sheathing. Install roof underlayment and ice and water shield. Replicate missing concrete tiles and reinstall roof tiles.

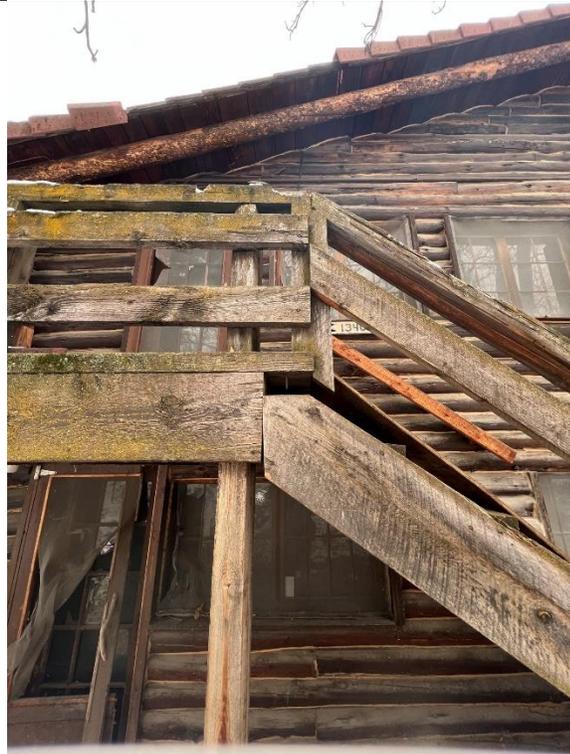
1.D	At east exterior stair, stringers not attached to landing	1.D.1	Restrict access to stairs	Positively attach stringers to landing framing
1.E	Wood floor joists cut and inadequately spliced below northeast bathroom	1.E.1-2	Restrict access to northeast bathroom	Sister new floor joists at existing spliced joists

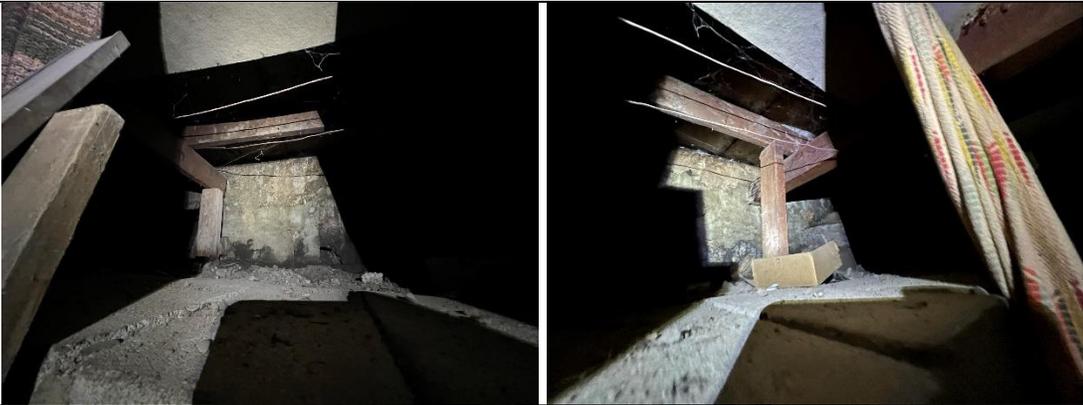
1.F.1&2

1.F	Posts and beams not positively attached to each other	1.F.1-2	N/A	Positively attach
1.G	At basement stair, termite damage in walls	1.G.1	Investigation by an exterminator of the Allen house and all structures on the property for termites. Extermination of termites in the Allen House	Remove and replace termite damaged wood

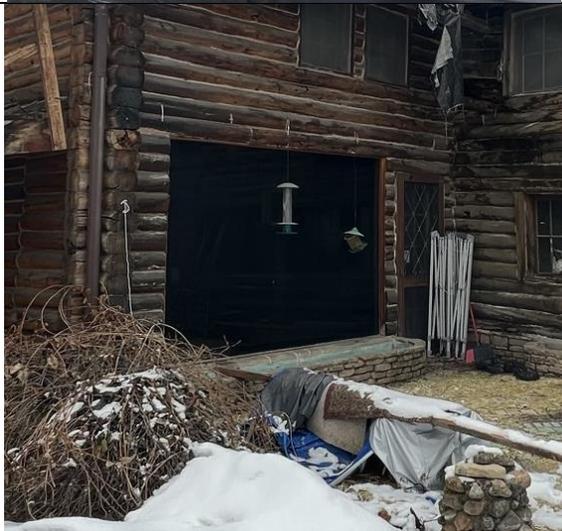
1.J	Beam over southeast window is discontinuous, loading the glass and window frame	1.J.1	N/A	Install new structural header and posts above window
1.K	Settlement at east wing near stone chimneys	1.K.1	N/A	Shore stone chimneys and walls using micropiles or helical piers

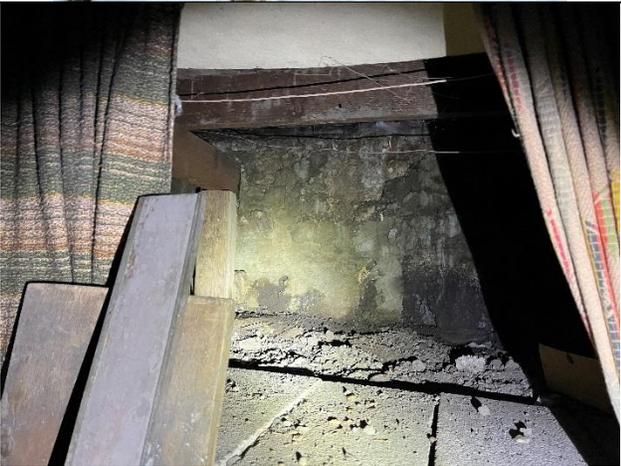
1.L	Roof sagging at doorways on either side of chimney where roof purlins were cut and have no support		N/A	Install new structural headers
1.M	Skim coat of concrete applied to masonry foundations	1.M.1	N/A	Install structural reinforced shotcrete wall at unreinforced masonry walls

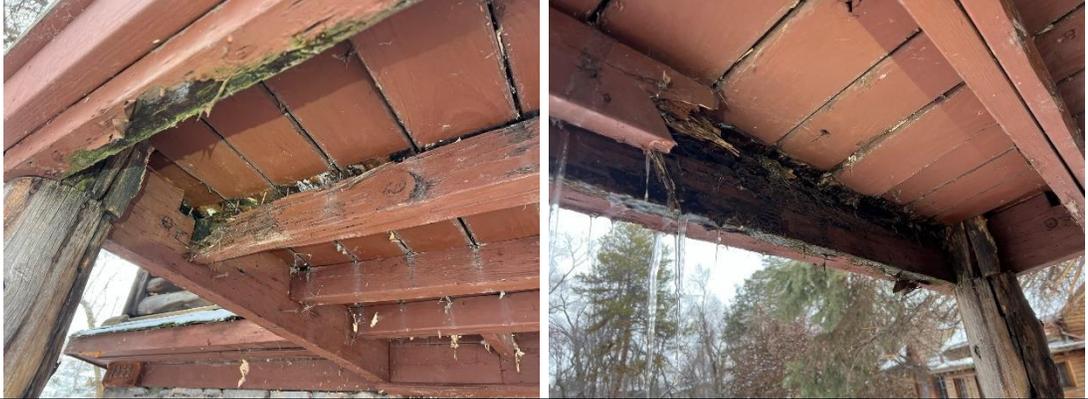
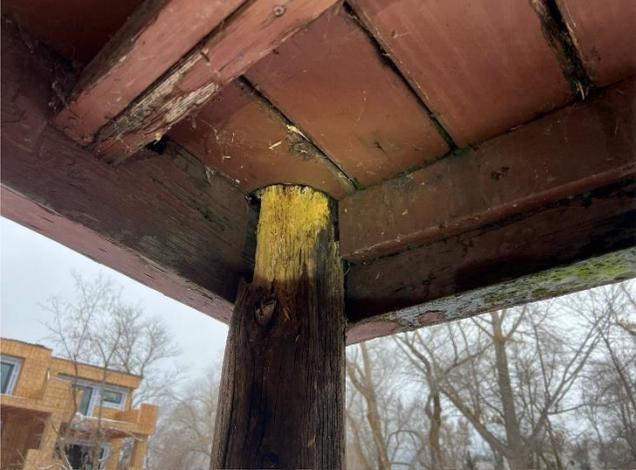
PHOTOS	
2.A.1-2

ITEM	DEFICIENCIES	PHOTOS	SHORT-TERM REPAIRS (0-5 YEARS)	LONG-TERM REPAIRS (25 YEARS)
2.A	Deteriorating framing at balcony	2.A.1-3	Restrict access to balcony	Remove and replace deteriorating framing members
2.B	Stairs posts are buried in the soil	2.B.1	N/A	Remove soil around posts and bear posts on concrete footing
2.C	Stone foundation walls	2.C.1-2	N/A	Install structural reinforced shotcrete wall at stone walls
2.D	Fire damage at west wall	2.D.1-2	N/A	Remove and replace fire damaged framing
2.E	Roof shingles are damaged and exceed their life span	2.E.1-2	Install ½" plywood sheathing over existing shingles and SBS self-adhering granule-surfaced modified-bitumen rolled roofing membrane	Install plywood sheathing, underlayment, ice and water shield and historically appropriate shingles

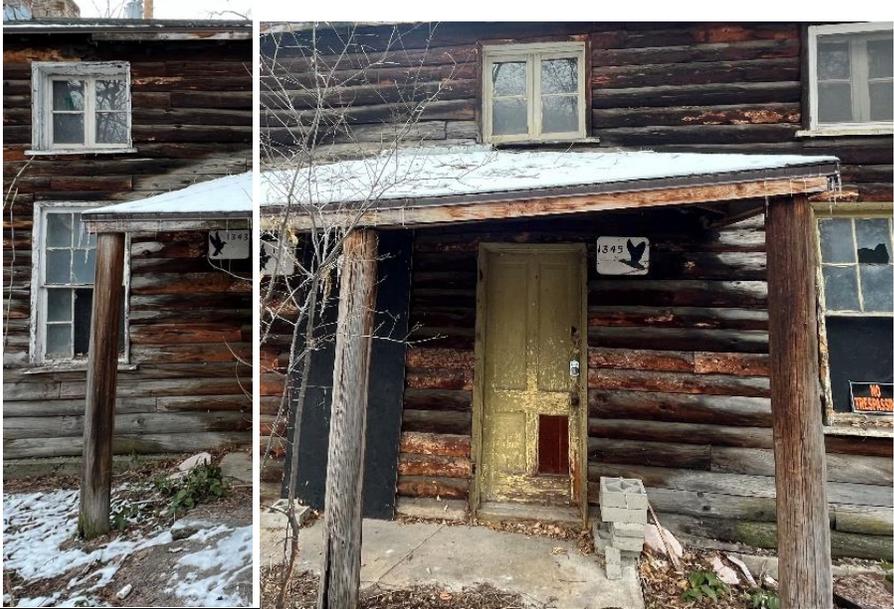
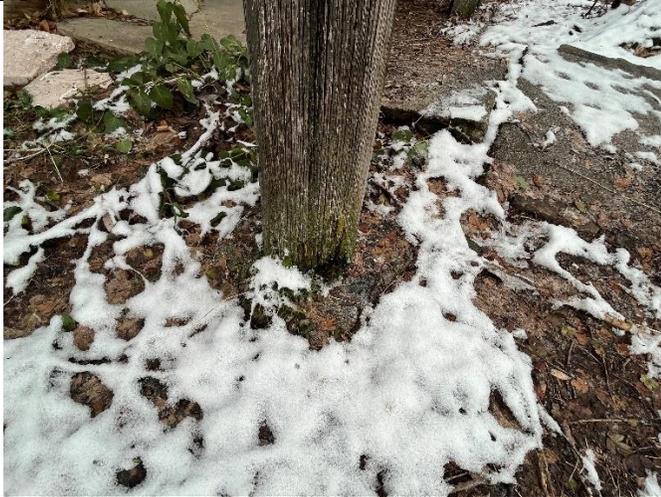
PHOTOS	
3.A.1-2

ITEM	DEFICIENCIES	PHOTOS	SHORT-TERM REPAIRS (0-5 YEARS)	LONG-TERM REPAIRS (25 YEARS)
3.A	Deteriorating post at canopy	3.A.1-2	N/A	Remove and replace deteriorating post. Remove soil around posts and bear posts on concrete footing
3.B	Logs bowing toward inside of building at north wall	3.B.1	Install temporary wood strong backs and attach each log to strongback	Align logs on top of each other and install tie rods through logs
3.C	Roof shingles are damaged and exceed their life span		Install ½” plywood sheathing over existing shingles and SBS self-adhering granule-surfaced modified-bitumen rolled roofing membrane	Install plywood sheathing, underlayment, ice and water shield and historically appropriate shingles

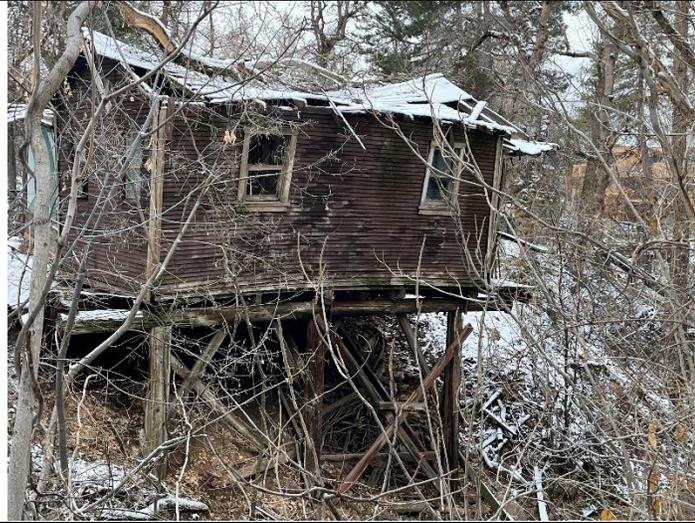
4.A.2

ITEM	DEFICIENCIES	PHOTOS	SHORT-TERM REPAIRS (0-5 YEARS)	LONG-TERM REPAIRS (25 YEARS)
4.A	Roof collapsed		Restrict access	Demo and rebuild if desired
4.B	Loss of building support in ravine		Restrict access	Demo and rebuild if desired

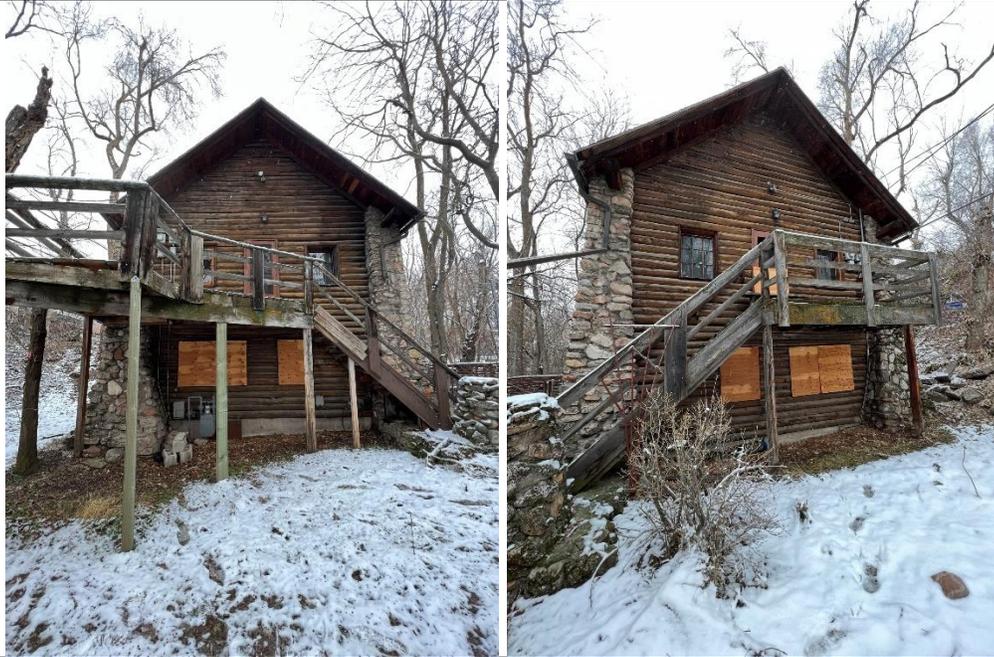
ITEM	DEFICIENCIES	PHOTOS	SHORT-TERM REPAIRS (0-5 YEARS)	LONG-TERM REPAIRS (25 YEARS)
5.A	Stairs posts are buried in the soil	5.A.1-2	N/A	Remove soil around posts and bear posts on concrete footing

5.B	West balcony is not adequately attached back to main structure	5.A.2	N/A	Positively attached balcony to main structure
5.C	Deteriorating logs at south and north wall	5.C.1-3	N/A	Remove and replace deteriorating wall log

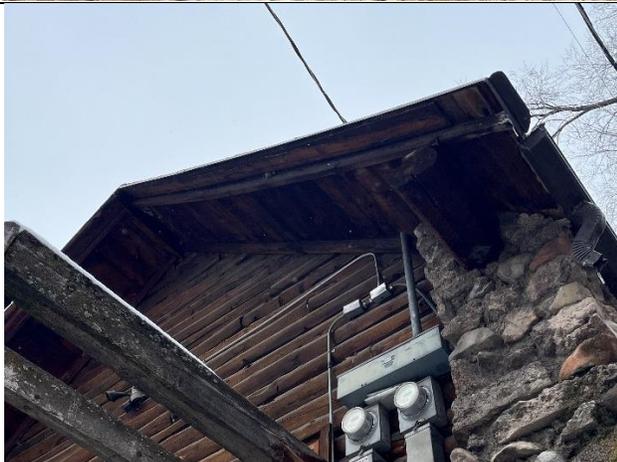
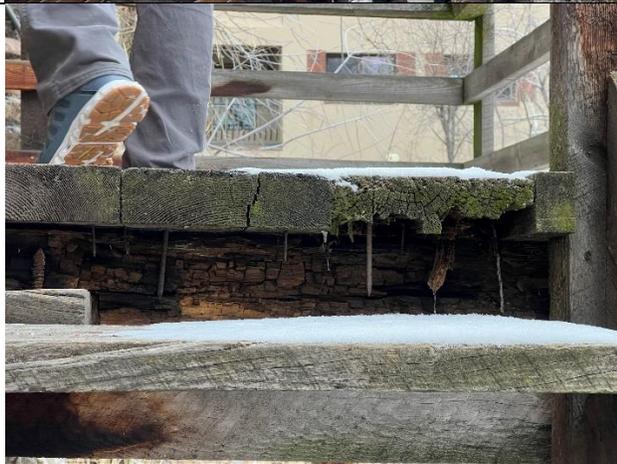
5.D	Roof sagging at eaves.	5.D.1	N/A	Sister new joist to existing joist
5.E	Deteriorating framing at east stair landing	5.E.1	Restrict access to stairs	Remove and replace deteriorating framing

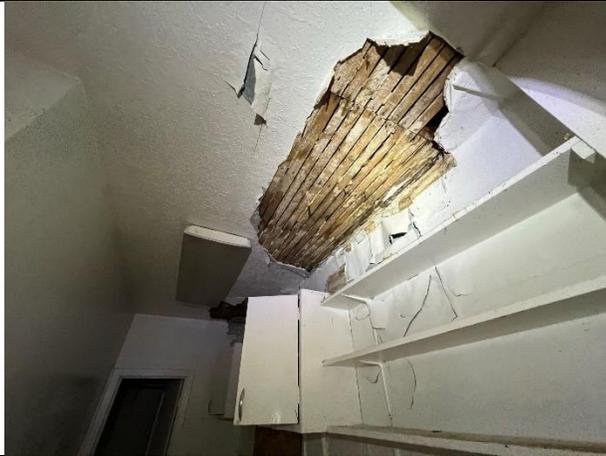
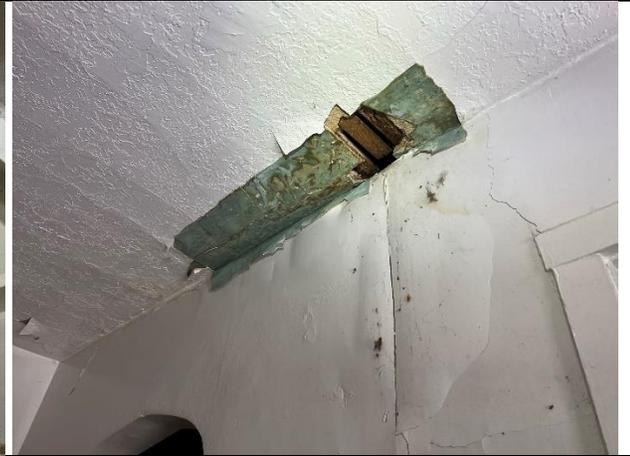
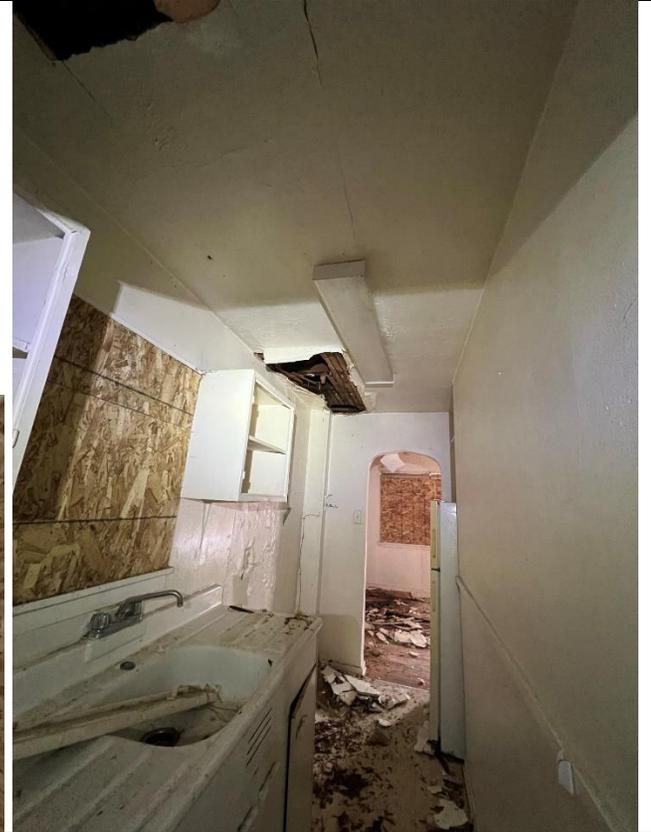
6.A.1-2

ITEM	DEFICIENCIES	PHOTOS	SHORT-TERM REPAIRS (0-5 YEARS)	LONG-TERM REPAIRS (25 YEARS)
6.A	Ceiling collapsed in some areas	6.A.1-4	N/A	Remove and replace water damaged ceiling framing
6.B	Deteriorating roof fascia boards and truss tails	6.B.1-2	N/A	Remove and replace deteriorating fascia boards and truss tails
6.C	Roof shingles are damaged and exceed their life span		Install ½" plywood sheathing over existing shingles and SBS self-adhering granule-surfaced modified-bitumen rolled roofing membrane	Install plywood sheathing, underlayment, ice and water shield and historically appropriate shingles
6.D	Unreinforced masonry foundation walls		N/A	Install structural reinforced shotcrete wall at unreinforced masonry foundation walls

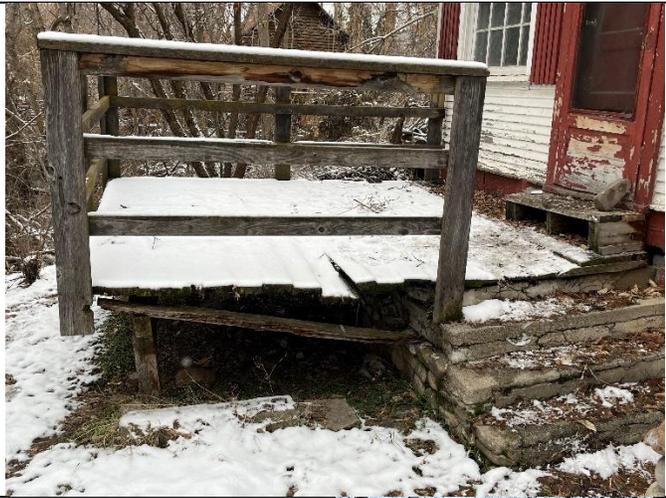
PHOTOS	
7.A.1

ITEM	DEFICIENCIES	PHOTOS	SHORT-TERM REPAIRS (0-5 YEARS)	LONG-TERM REPAIRS (25 YEARS)
7.A	Deteriorating at balcony framing and posts	7.A.1	Restrict access to south side of balcony	Remove and replace deteriorating framing and posts
7.B	Ceiling collapsed in some areas		N/A	Remove and replace water damaged ceiling framing
7.C	Deteriorating roof fascia boards and truss tails	7.C.1-4	N/A	Remove and replace deteriorating fascia boards and truss tails
7.D	Roof shingles are damaged and exceed their life span		Install ½” plywood sheathing over existing shingles and SBS self-adhering granule-surfaced modified-bitumen rolled roofing membrane	Install plywood sheathing, underlayment, ice and water shield and historically appropriate shingles
7.E	Unreinforced masonry foundation walls		N/A	Install structural reinforced shotcrete wall at unreinforced masonry foundation walls

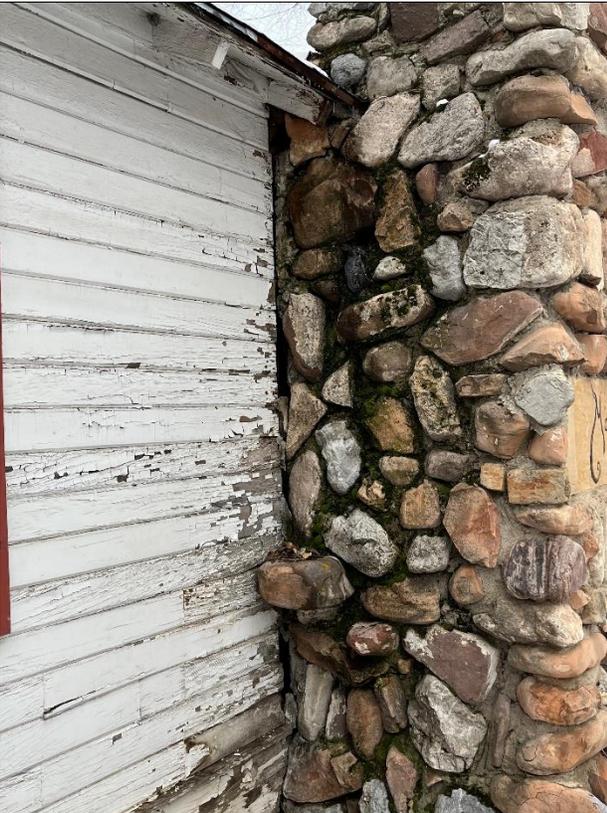
PHOTOS	
8.B.1

ITEM	DEFICIENCIES	PHOTOS	SHORT-TERM REPAIRS (0-5 YEARS)	LONG-TERM REPAIRS (25 YEARS)
8.A	Ceiling collapsed in some areas		N/A	Remove and replace water damaged ceiling framing
8.B	Deterioration of siding near chimney	8.B.1	N/A	Remove and replace deteriorating siding and wall framing
8.C	Roof shingles are damaged and exceed their life span		Install ½" plywood sheathing over existing shingles and SBS self-adhering granule-surfaced modified-bitumen rolled roofing membrane	Install plywood sheathing, underlayment, ice and water shield and historically appropriate shingles

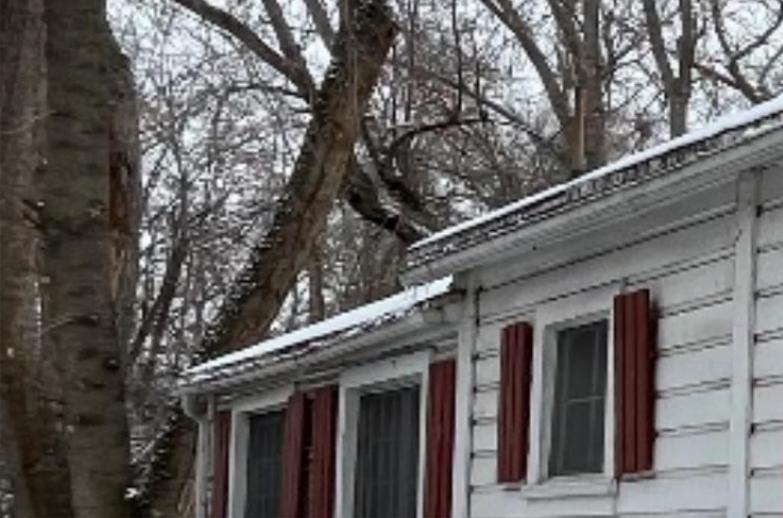
PHOTOS	
10.B.1

ITEM	DEFICIENCIES	PHOTOS	SHORT-TERM REPAIRS (0-5 YEARS)	LONG-TERM REPAIRS (25 YEARS)
10.A	Ceiling collapsed in some areas		N/A	Remove and replace water damaged ceiling framing
10.B	Deteriorating roof fascia boards	10.B.1	N/A	Remove and replace deteriorating fascia boards
10.C	Roof shingles are damaged and exceed their life span	10.C.1	Install ½” plywood sheathing over existing shingles and SBS self-adhering granule-surfaced modified-bitumen rolled roofing membrane	Install plywood sheathing, underlayment, ice and water shield and historically appropriate shingles
10.D	Foundation settlement		N/A	Shore foundation walls using micropiles or helical piers

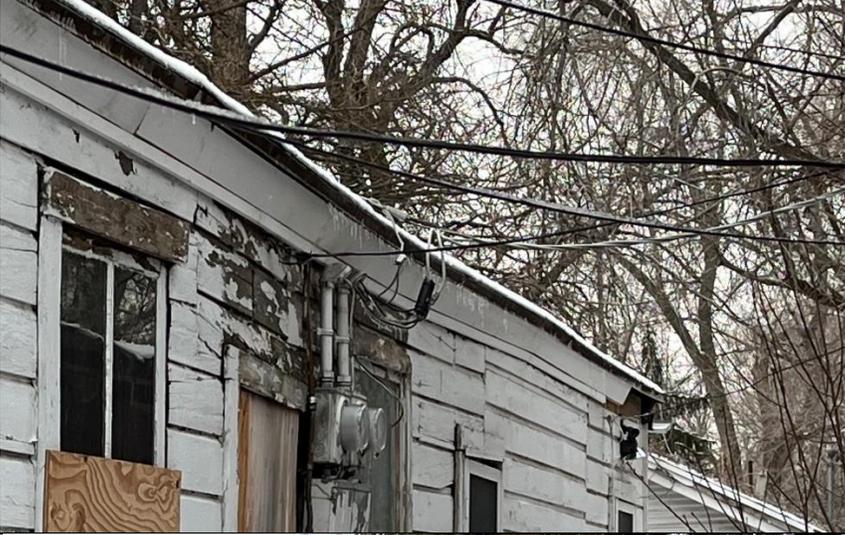
PHOTOS	
11.B.1

ITEM	DEFICIENCIES	PHOTOS	SHORT-TERM REPAIRS (0-5 YEARS)	LONG-TERM REPAIRS (25 YEARS)
11.A	Ceiling collapsed in some areas		N/A	Remove and replace water damaged ceiling framing
11.B	Deteriorating roof fascia boards	11.B.1	N/A	Remove and replace deteriorating fascia boards
11.C	Roof shingles are damaged and exceed their life span	11.C.1	Install ½" plywood sheathing over existing shingles and SBS self-adhering granule-surfaced modified-bitumen rolled roofing membrane	Install plywood sheathing, underlayment, ice and water shield and historically appropriate shingles
11.D	Canopy framing is pulling away from main structure	11.D.1	N/A	Positively attach canopy framing to main structure

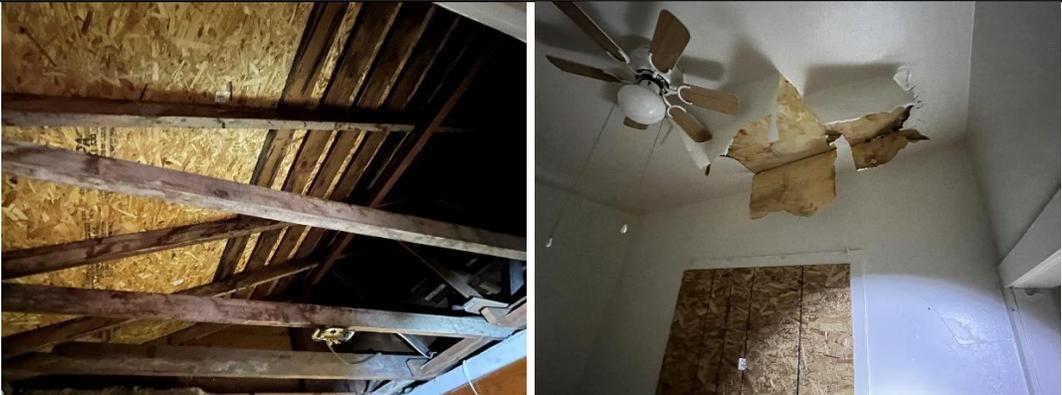
PHOTOS	
12.A.1-2

ITEM	DEFICIENCIES	PHOTOS	SHORT-TERM REPAIRS (0-5 YEARS)	LONG-TERM REPAIRS (25 YEARS)
12.A	Ceiling collapsed in some areas	12.A.1-2	N/A	Remove and replace water damaged ceiling framing
12.B	Deteriorating roof fascia boards	12.B.1	N/A	Remove and replace deteriorating fascia boards
12.C	Roof shingles are damaged and exceed their life span	12.C.1	Install ½" plywood sheathing over existing shingles and SBS self-adhering granule-surfaced modified-bitumen rolled roofing membrane	Install plywood sheathing, underlayment, ice and water shield and historically appropriate shingles
12.D	Deterioration at canopy framing	12.D.1-2	N/A	Remove and replace deteriorating canopy framing
12.E	Settlement at canopy stone columns	12.E.1	N/A	Shore and straighten stone columns

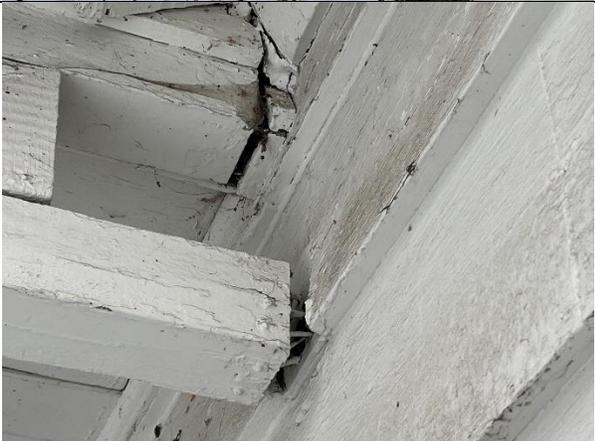
ITEM	DEFICIENCIES	PHOTOS	SHORT-TERM REPAIRS (0-5 YEARS)	LONG-TERM REPAIRS (25 YEARS)
13.A	Ceiling collapsed in some areas		N/A	Remove and replace water damaged ceiling framing
13.B	Roof shingles are damaged and exceed their life span		Install ½" plywood sheathing over existing shingles and SBS self-adhering granule-surfaced modified-bitumen rolled roofing membrane	Install plywood sheathing, underlayment, ice and water shield and historically appropriate shingles
13.C	Foundation settlement	13.C.1	N/A	Shore foundation walls using micropiles or helical piers
13.D	Canopy framing is pulling away from main structure	13.D.1	N/A	Positively attach canopy framing to main structure

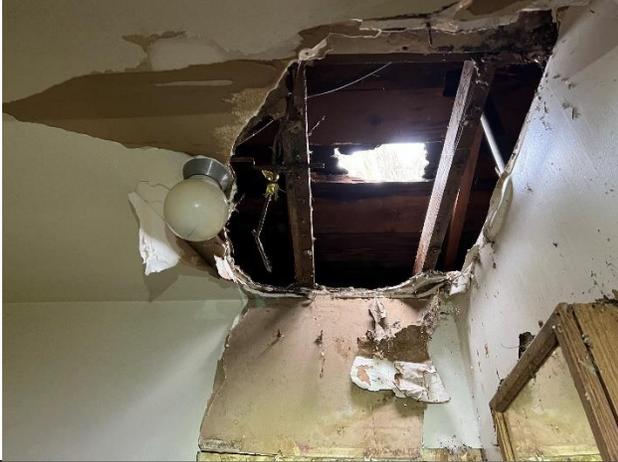
PHOTOS				
14.A.1

ITEM	DEFICIENCIES	PHOTOS	SHORT-TERM REPAIRS (0-5 YEARS)	LONG-TERM REPAIRS (25 YEARS)
14.A	Holes in roof allowing rain and snow to enter building	14.A.1	Cover holes to prevent water penetration	Remove and replace damaged wood sheathing and roof tiles

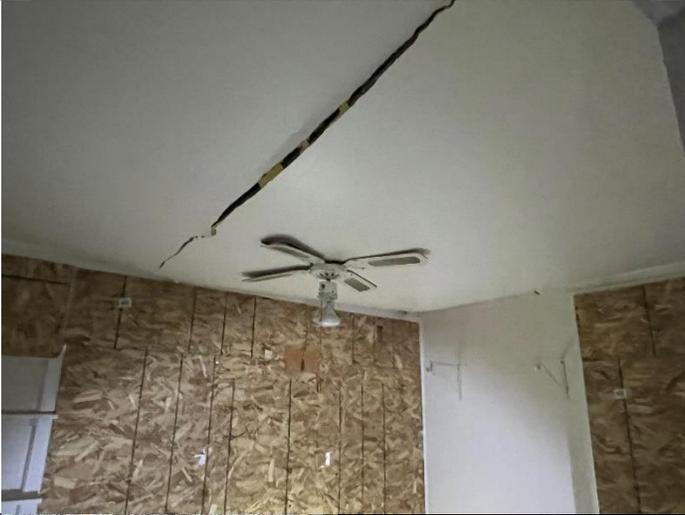
14.B.1-2

14.B	Ceiling collapsed in some areas	14.B.1	N/A	Remove and replace water damaged ceiling framing
14.C	Roof shingles are damaged and exceed their life span		Install ½" plywood sheathing over existing shingles and SBS self-adhering granule-surfaced modified-bitumen rolled roofing membrane	Install plywood sheathing, underlayment, ice and water shield and historically appropriate shingles

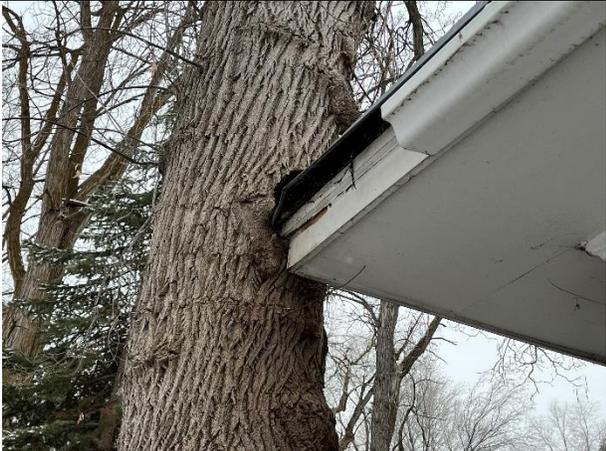
14.D	Deteriorating roof fascia boards	14.D.1-2	N/A	Remove and replace deteriorating fascia boards
14.E	Tree growing against canopy framing	14.E.1	N/A	Remove tree

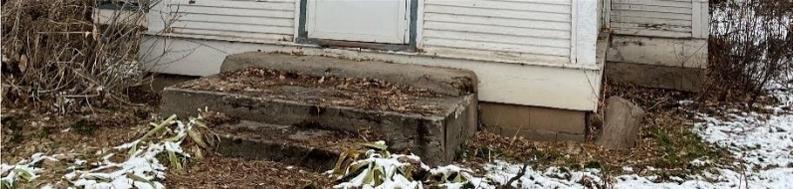
14.F	Unreinforced masonry foundation walls	14.F.1	N/A	Install structural reinforced shotcrete wall at

unreinforced masonry foundation walls
--	--	--	--	---

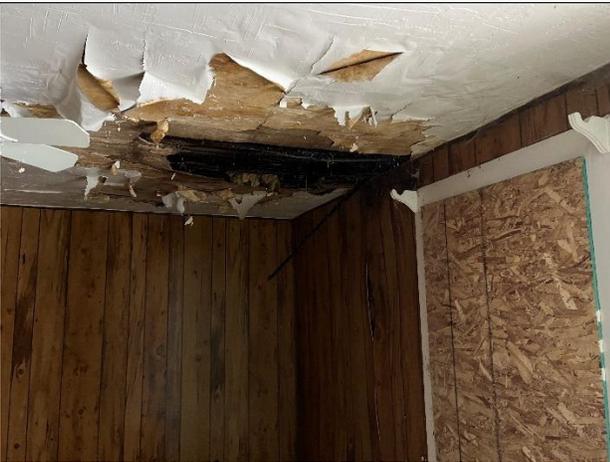
PHOTOS	
15.A.1

ITEM	DEFICIENCIES	PHOTOS	SHORT-TERM REPAIRS (0-5 YEARS)	LONG-TERM REPAIRS (25 YEARS)
15.A	Ceiling collapsed in some areas	15.A.1	N/A	Remove and replace water damaged ceiling framing

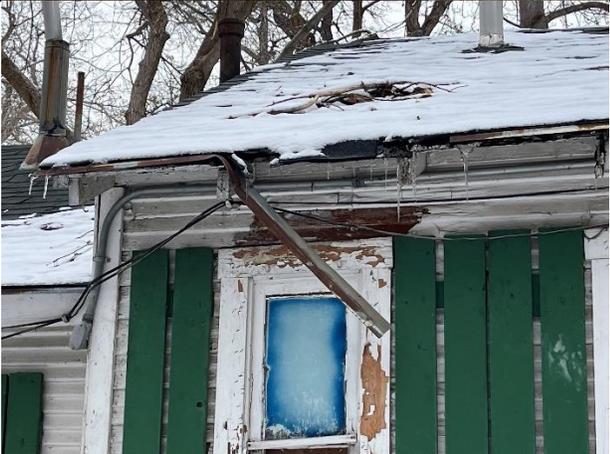
15.B	Deteriorating roof truss tails	15.B.1	N/A	Remove and replace deteriorating truss tails
15.C	Roof shingles are damaged and exceed their life span		Install ½" plywood sheathing over existing shingles and SBS self-adhering granule-surfaced modified-bitumen rolled roofing membrane	Install plywood sheathing, underlayment, ice and water shield and historically appropriate shingles

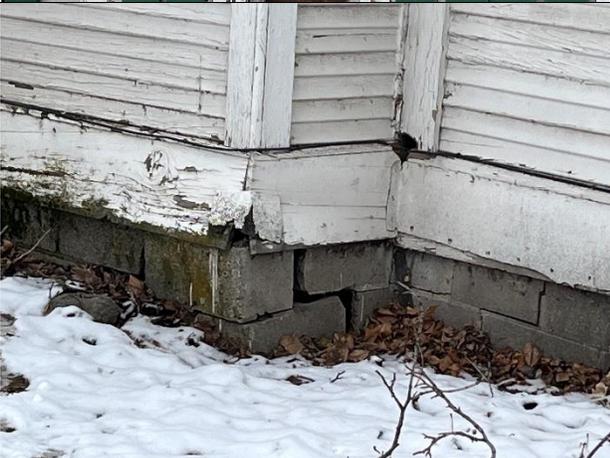
15.D	Foundation settlement	15.D.1	N/A	Shore foundation walls using micropiles or helical piers
15.E	Canopy framing is pulling away from main structure	15.E.1	N/A	Positively attach canopy framing to main structure

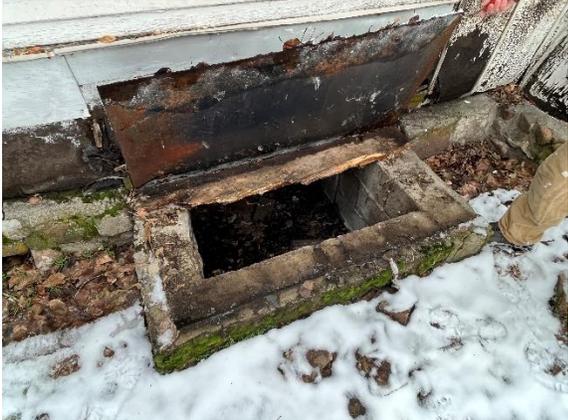
15.F	Unreinforced masonry foundation walls	15.F.1	N/A	Install structural reinforced shotcrete wall at unreinforced masonry foundation walls
