Concord and Glendale Intersections Pedestrian Safety Study

CALIFORNIA AVE PEDESTRIAN SAFETY STUDY

RECOMMENDATIONS REPORT

August 22, 2023

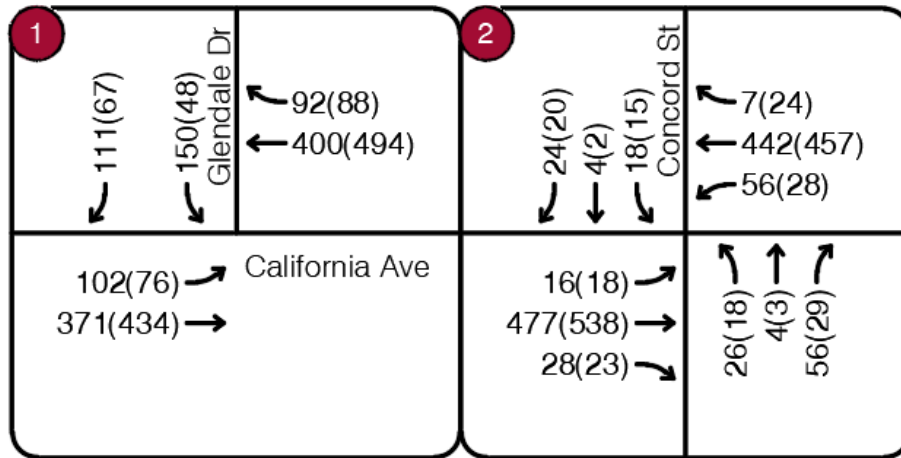
Figure 2 – 2023 Existing Peak Hour Traffic Volumes

Peak hour traffic volumes at study area intersections are shown in **Figure 2**.

1: California Ave/Glendale Dr, 2: California Ave/Concord St

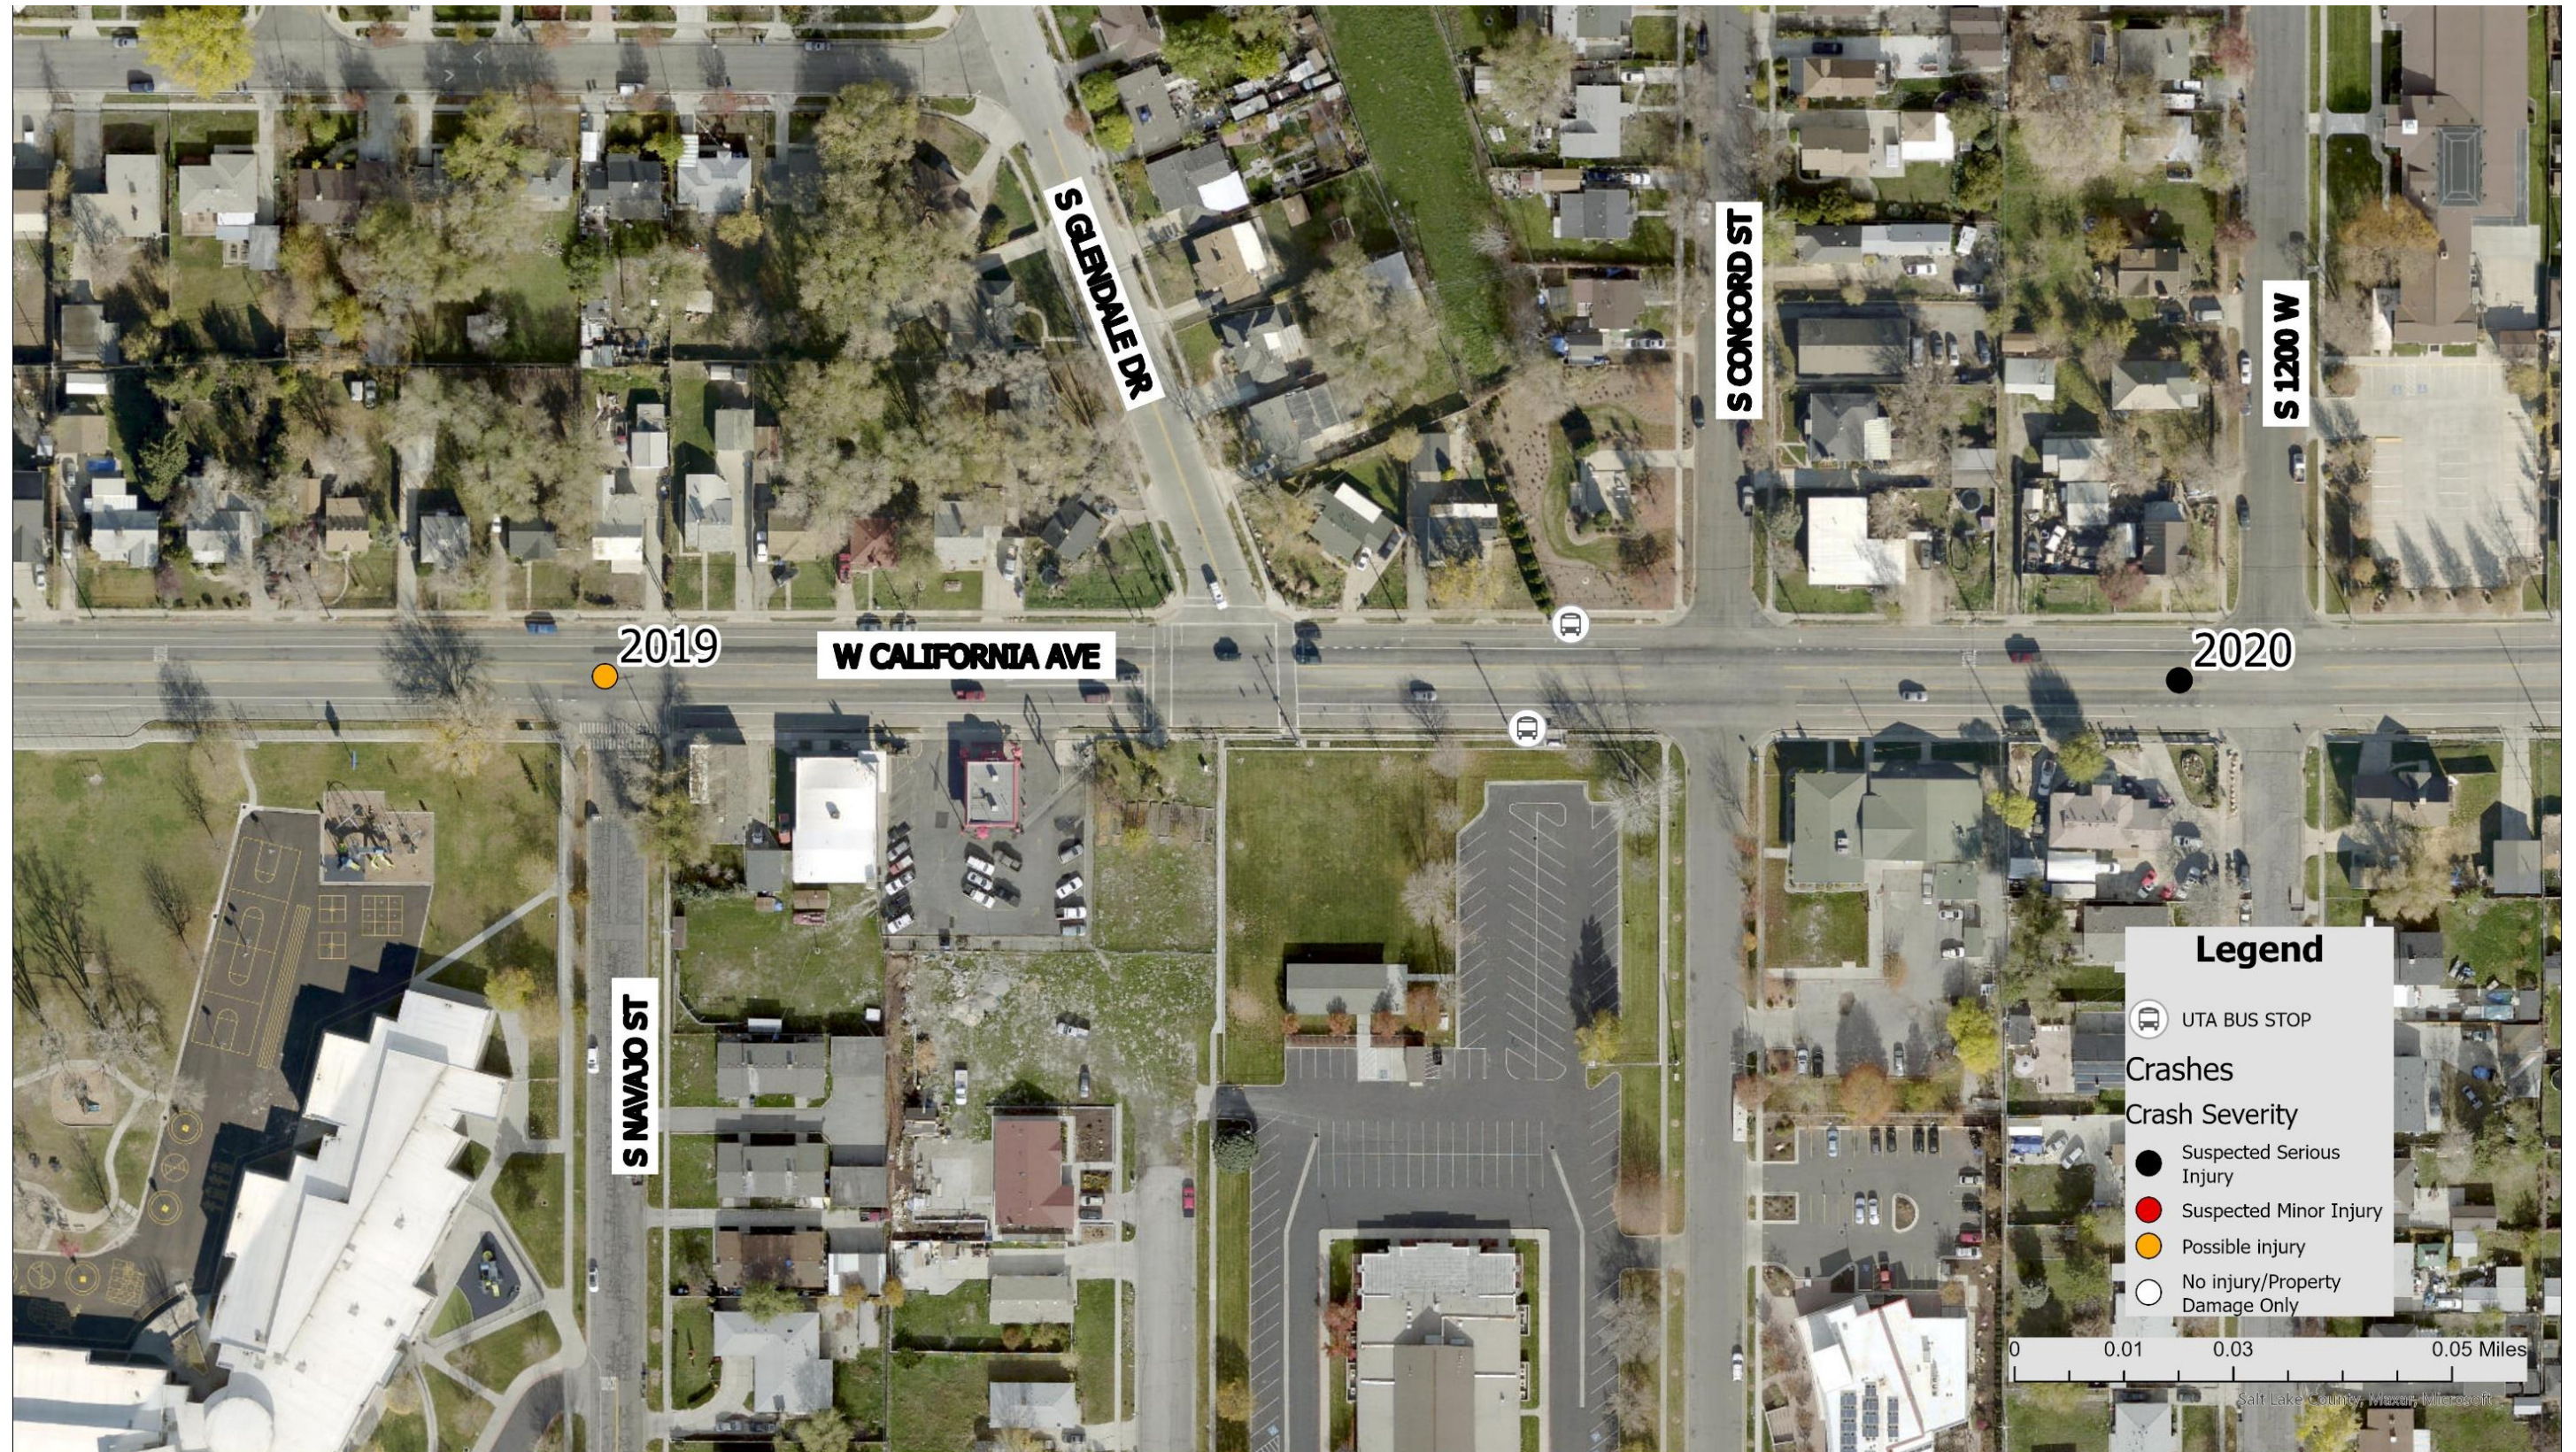
Figure 3 – Pedestrian Crashes by Severity

Crash data were obtained from UDOT’s crash database for the years 2010 through 2021. A total of 65 crashes were reported within the study area during that period with two of the crashes involving pedestrians and two crashes involving bicyclists. There were no fatal crashes reported during the analysis period. Pedestrian crashes, bicycle crashes, and total crashes by location are shown in **Figure 3**, **Figure 4**, and **Figure 5** respectively. Crash data are included in **Appendix F**.

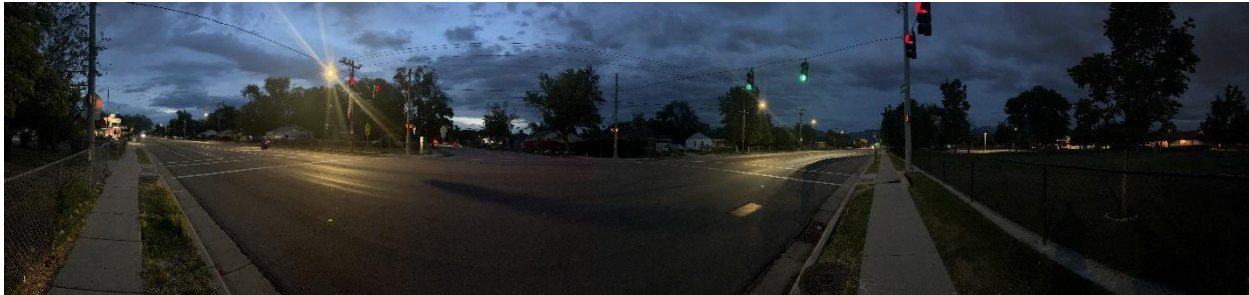
Photograph 1 - Example of Low Lighting Levels at Intersection

The field review team observed low intersection lighting at crosswalks, particularly on the east leg of the crosswalk. See **Photograph 1**.

Suggestion: Upgrade traffic signal with new intersection lighting

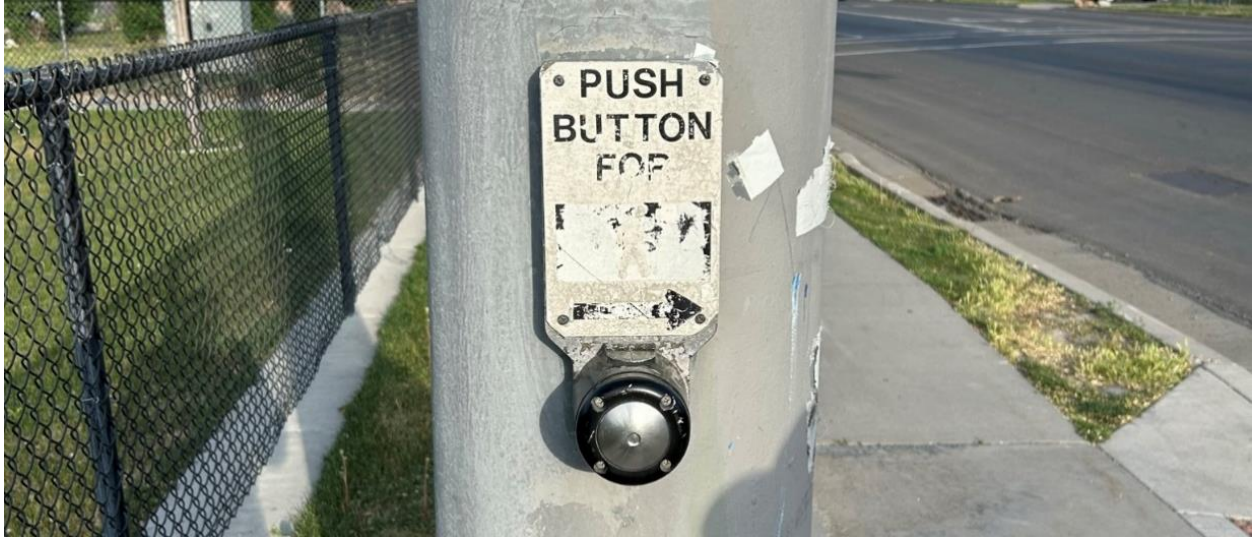
Photograph 2 – Example of Weathered Crosswalk Push Button Sign

The field review team observed that some of the crosswalk push buttons need of refurbishment or replacement. See **Photograph 2**.

Suggestion: Upgrade traffic signal with new push buttons signs or replace/refurbish existing push button signs.

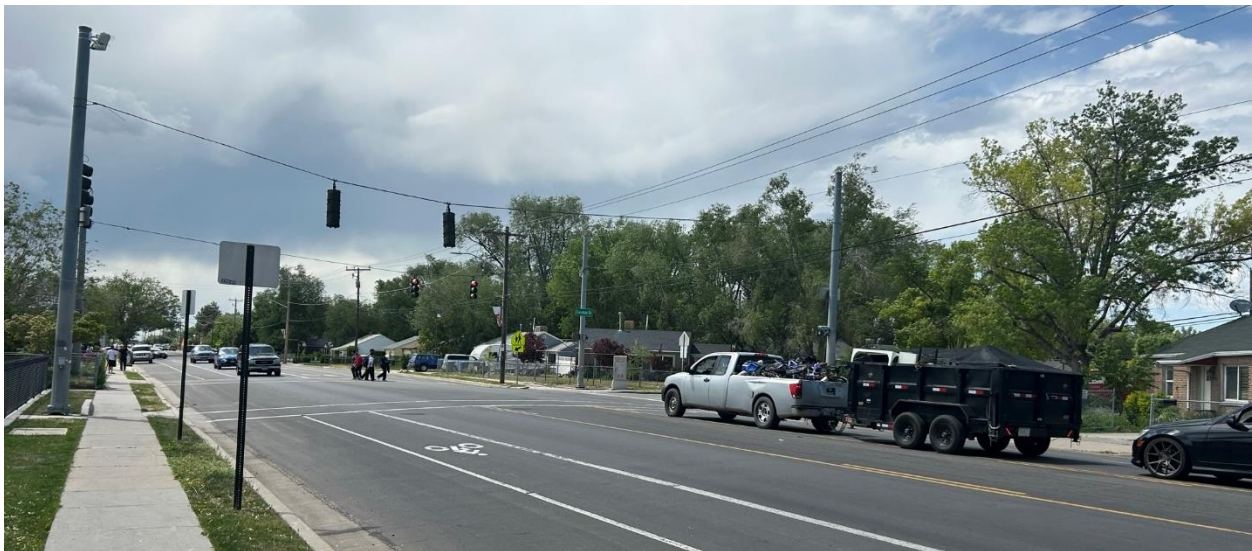
Photograph 3 – Existing ladder-style crosswalk pavement markings

The Glendale Dr/California Ave intersection crosswalks are a designated school crossing. Existing crosswalks are standard ladder crosswalks. See **Photograph 3** and **Photograph 4**.

Suggestion: Improve existing ladder-style crosswalk pavement markings to high-visibility crosswalk pavement markings

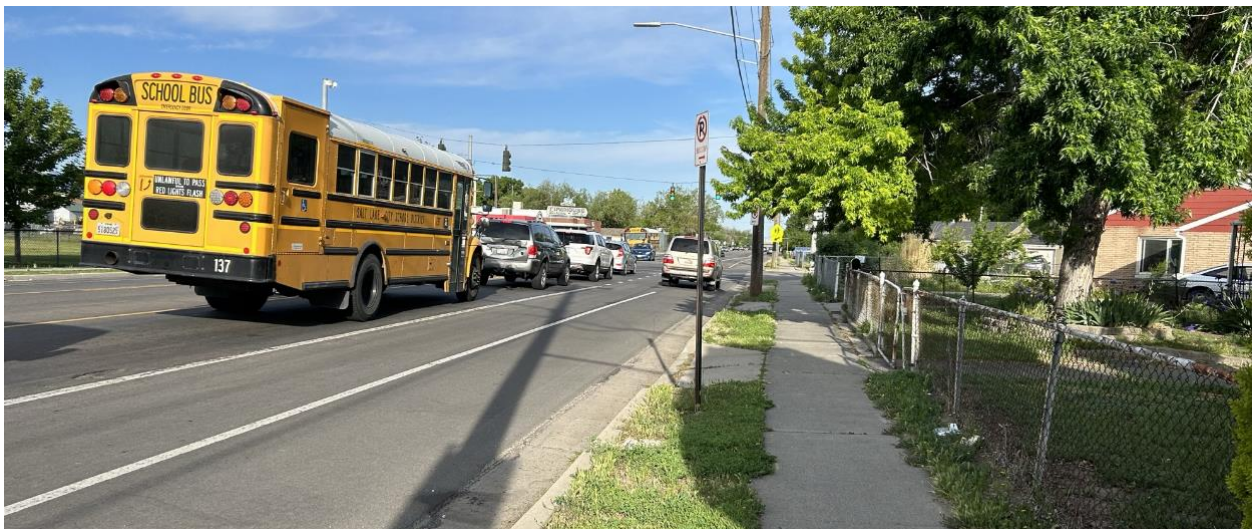
Photograph 5 – Vehicle crossing bike lane to make a right turn onto Glendale Dr.

Westbound California Ave includes a bike lane adjacent to on-street parking. As the lane approaches Glendale Drive, it transitions to a right turn lane for vehicles turning onto northbound Glendale Dr, presenting a potential conflict zone with people riding bicycles. See **Photograph 5**.

Suggestion: Install green pavement markings at intersection approach to Glendale Dr. indicating a bicycle/motor vehicle conflict zone.

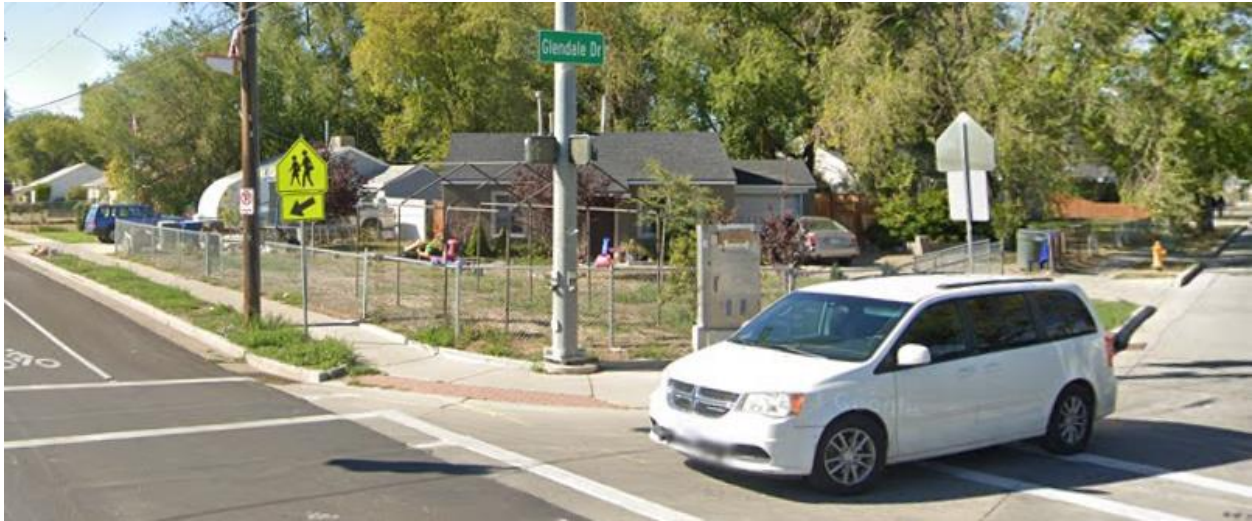
Photograph 6 – Wide Radius Right Turn Lane on Glendale Dr

The field review team observed large turning intersection turning radius. Vehicles tend to encroach into intersection when making a right turn on red. A large radius increases vehicle speeds when making a turn, potentially conflicting with pedestrians crossing California Ave. See **Photograph 6**.

Suggestion: Tighten right turn radius to shorten pedestrian crossing distance.

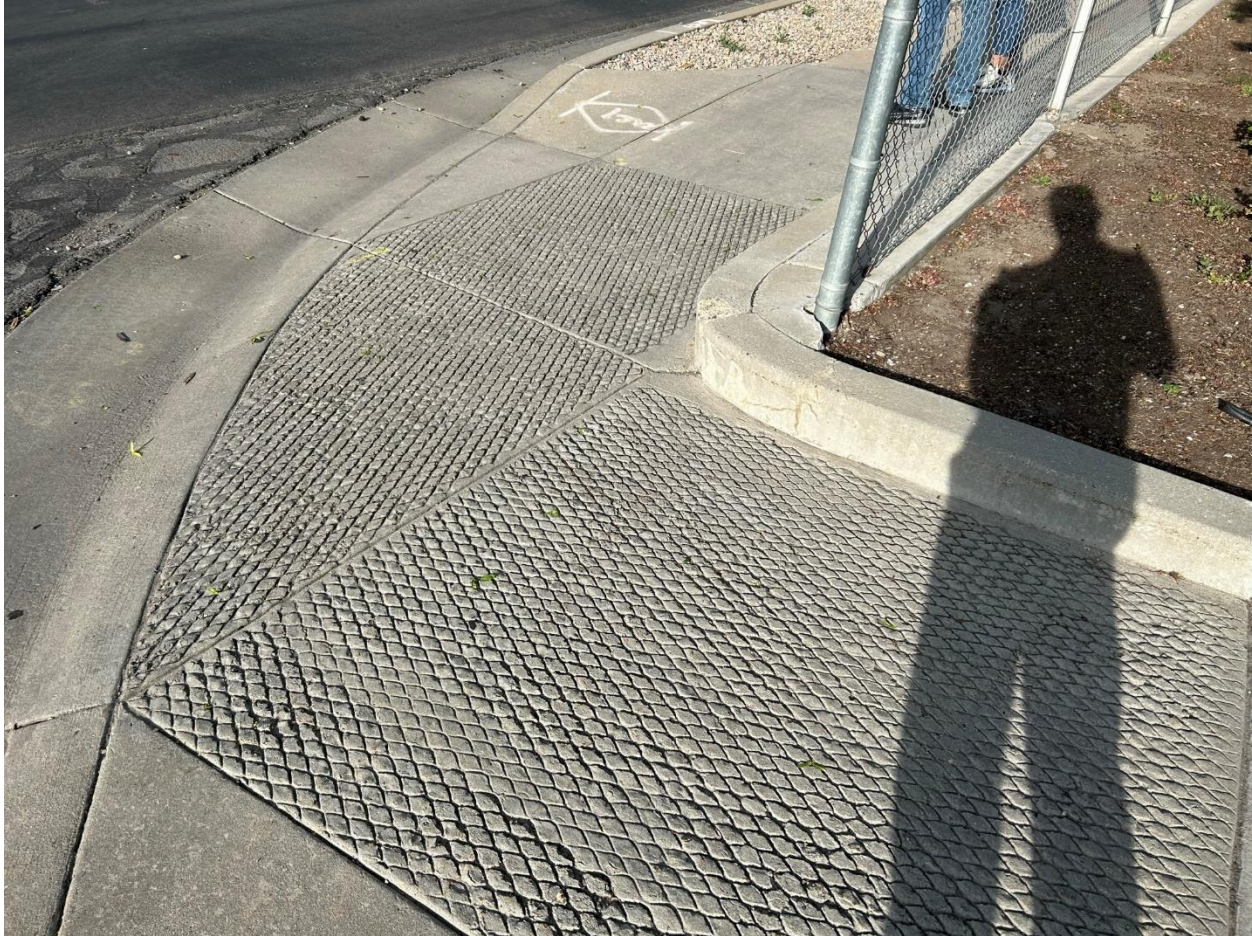
Photograph 7 – Pedestrian ramps do not meet current ADA standards

Several of the intersection pedestrian ramps do not meet current ADA standards with land areas and truncated dome warning strips. Furthermore, the apex-style ramps tend to direct pedestrians into the center of the intersection rather perpendicular to the roadway. See **Photograph 7**.

Suggestion: Improve pedestrian ramps to meet current ADA standards.

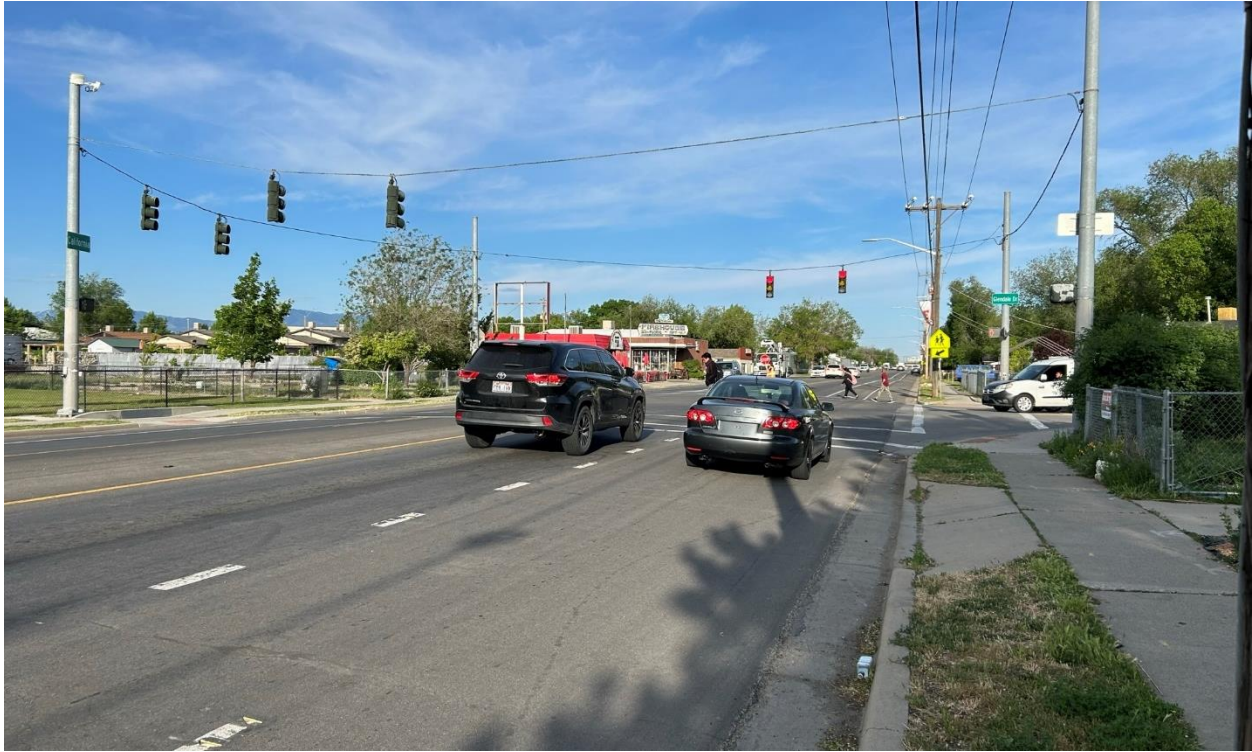
Photograph 8 – Pedestrians crossing California Avenue

The field review team observed significant pedestrian activity, particularly on the south side of California Ave. During school arrival and dismissal periods, students cross from the south side of California Avenue to the north side of the road. These crossings coincide with southbound green on Glendale Dr introducing potential conflicts with pedestrians. See **Photograph 8**.

Suggestion: Shorten pedestrian crossing distance for pedestrians by installing bulbouts on each intersection corner. Consider raised center island to provide pedestrian refuge. Consider a Leading Pedestrian Interval or an all-red pedestrian phase when pedestrian push button activated accompanied by “No Right Turn on Red When Pedestrians Present” signs.

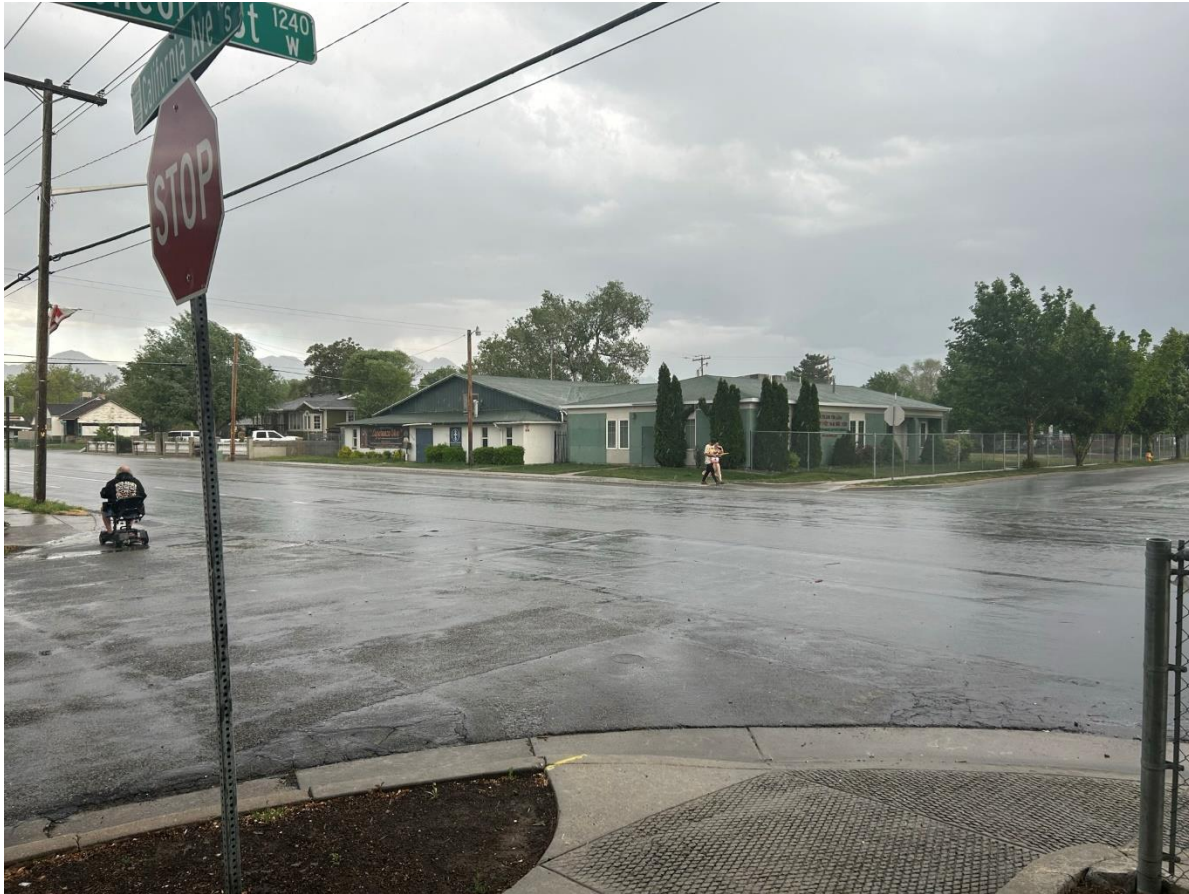
Photograph 9 - Large intersection radius at Concord St.

Large turning radius encourages vehicles to turn into bike lane. See *Photograph 9*.

Suggestion: Construct intersection bulb outs on each intersection corner. Geometry should consider snowplow and buses.

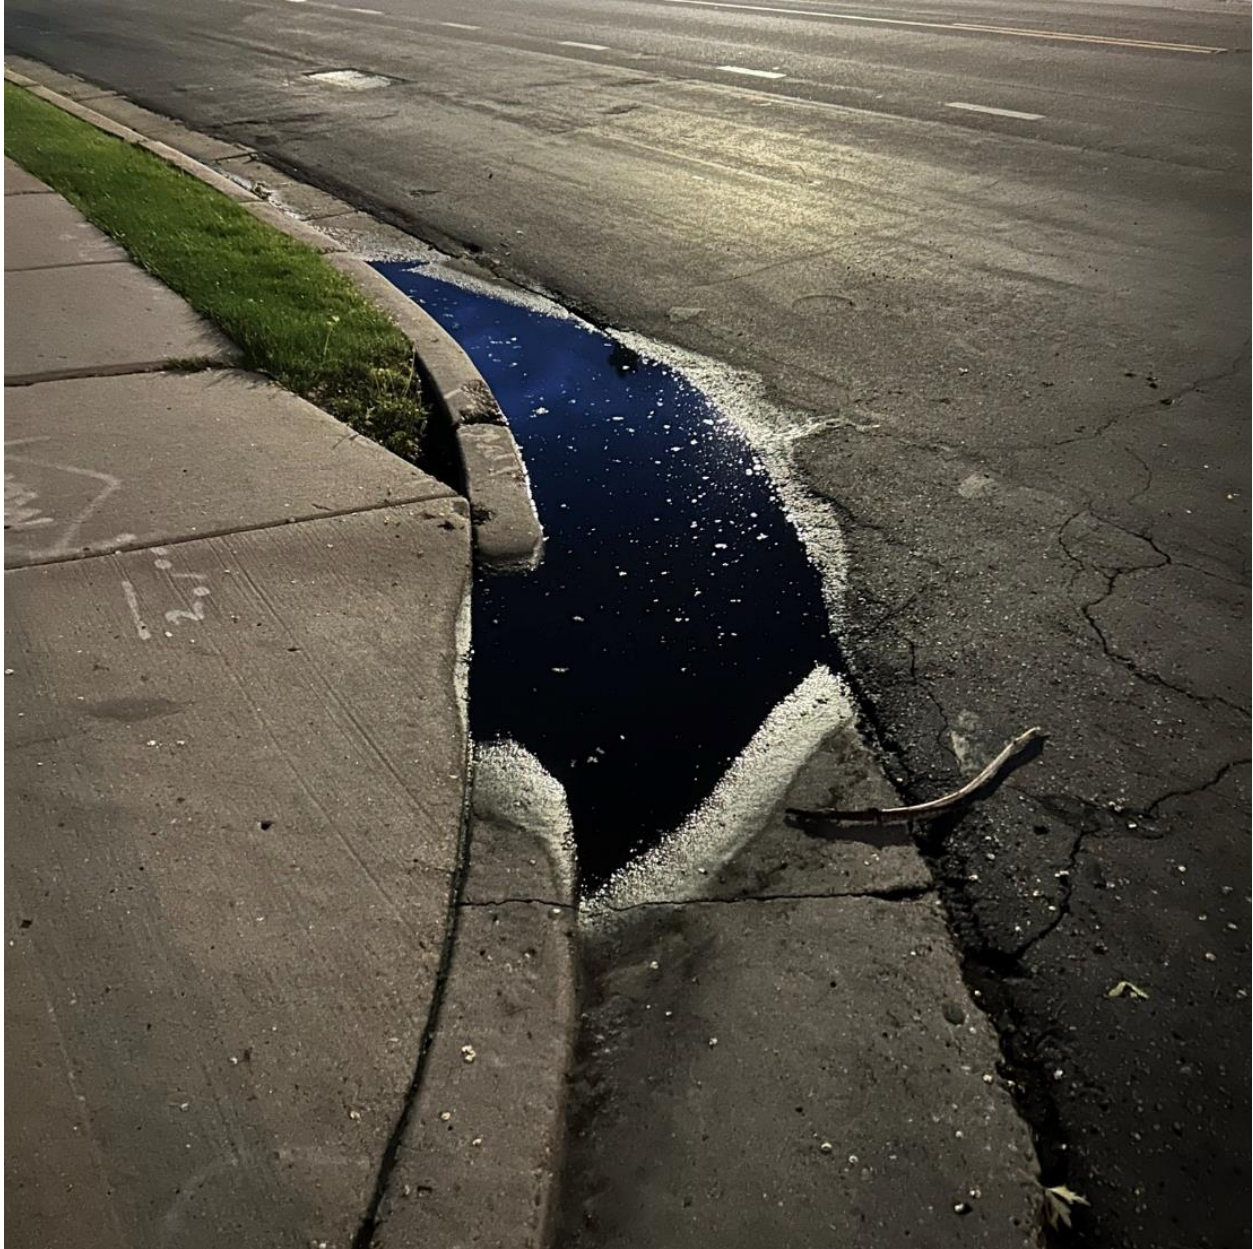
Photograph 10 – Water Pooling on Southwest Corner

Pedestrian ramps do not meet current ADA requirements (northwest, northeast, southeast corners). In addition, water ponding was observed on southwest corner of the intersection. See **Photograph 10**.

Suggestion: Improve pedestrian ramps to meet current ADA standards.

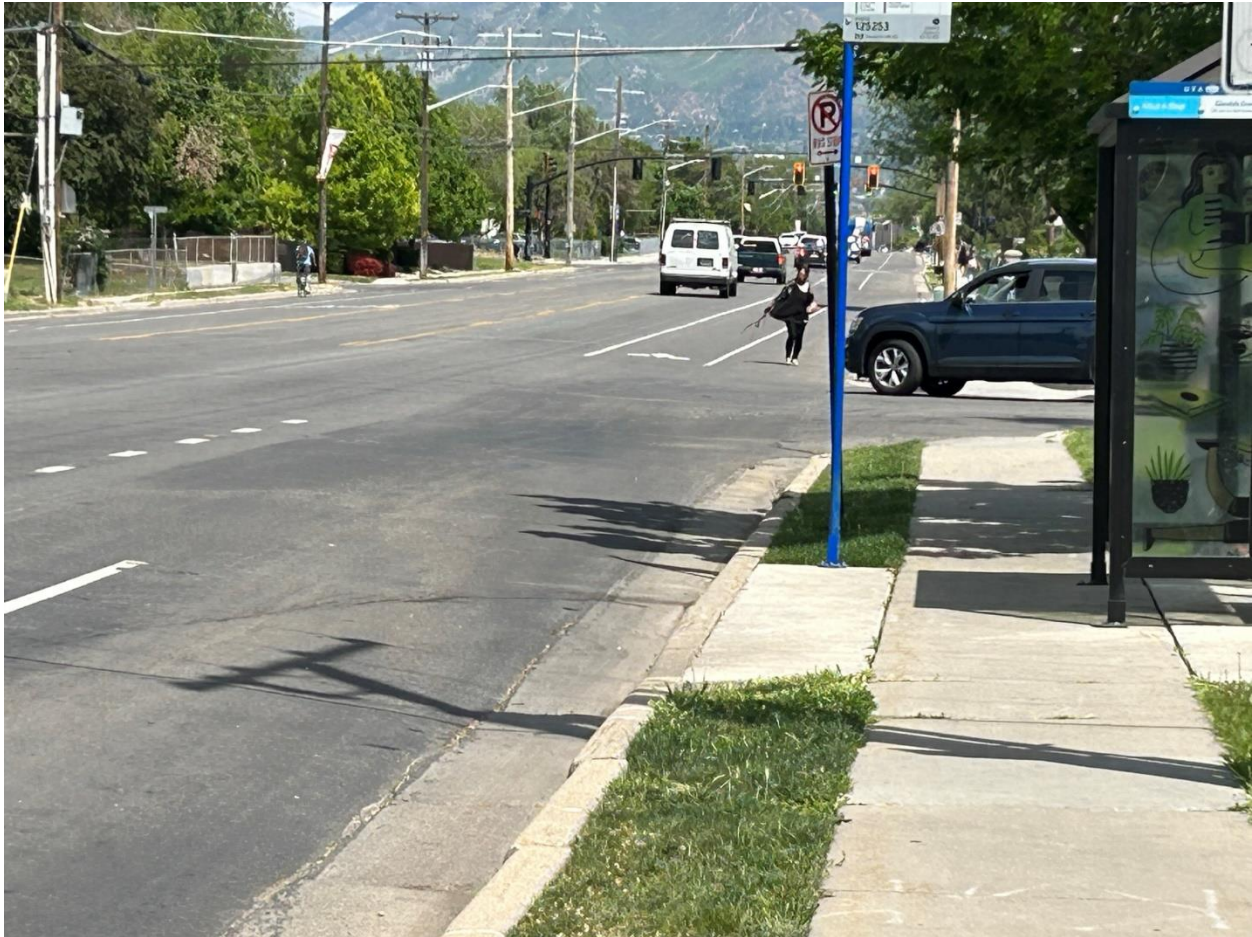
Photograph 11 – Pedestrian Crossing California Ave

Pedestrians were observed walking from the bus stop on the south side of California Ave to the north side of California Ave. There are no striped crosswalks at this intersection. See **Photograph 11**.

Suggestion: Construct intersection bulbouts to shorten crossing distance, construct marked crosswalk enhanced with a Rectangular Rapid Flashing Beacon, and a raised pedestrian refuge island.

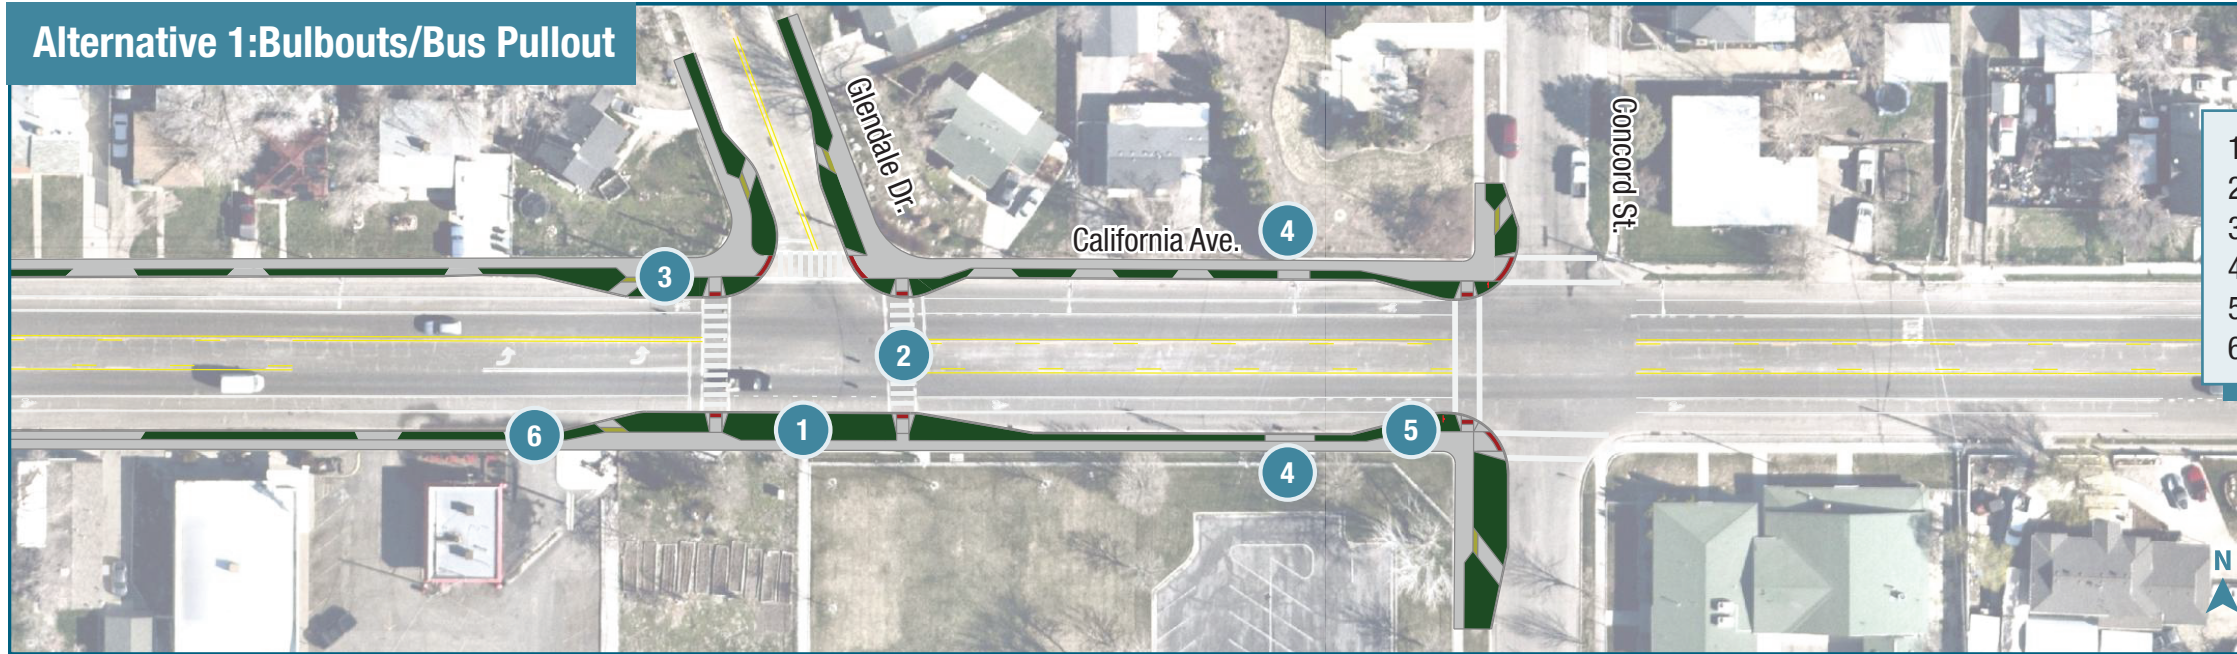
Figure 6 – Improvement Summary

The improvements are summarized in **Figure 6**, and detailed in **Figure 7**, **Figure 8**, and **Figure 9**.

- 1. New Traffic Signal (Improve Existing) with Lighting
- 2. High Visibility Crosswalks
- 3. Intersection Bulbouts with Directional Ramps
- 4. Bus Pad with Shelter
- 5. Rectangular Rapid Flashing Beacon (RRFB)
- 6. Bike ramp access to or from sidewalk

- 1. New Traffic Signal (Improve Existing) with Lighting
- 2. High Visibility Crosswalks
- 3. Intersection Bulbouts with Directional Ramps
- 4. Bus Pad with Shelter
- 5. Rectangular Rapid Flashing Beacon (RRFB)
- 6. Bike ramp access to or from sidewalk
- 7. Raised Center Refuge Island

- 1. New Traffic Signal (Improve Existing) with Lighting
- 2. High Visibility Crosswalks
- 3. Intersection Bulbouts with Directional Ramps
- 4. Bus Pad with Shelter with In-Line Stops
- 5. Rectangular Rapid Flashing Beacon (RRFB)
- 6. Bike ramp access to or from sidewalk
- 7. Raised Center Refuge Island
- 8. Wide Sidewalk (South and North Side)
