# Facilities Condition Report

Allen Park Buildings

February 22, 2023  
(Revised August 10, 2023)

GSBS Architects  
&  
ARW Engineers

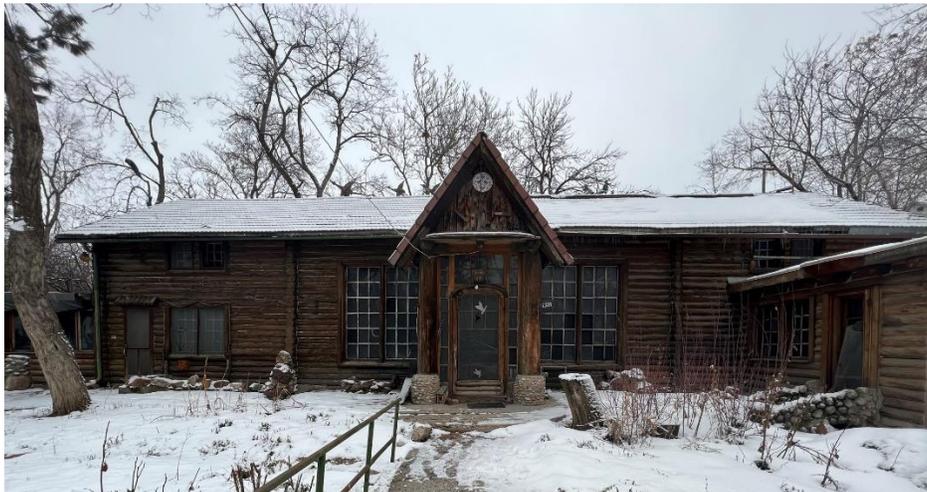
Figure 1: Allen House

- Two-story stacked log structure
- Stone and unreinforced masonry foundation
- Straight roof and floor sheathing
- Overall rating - Poor

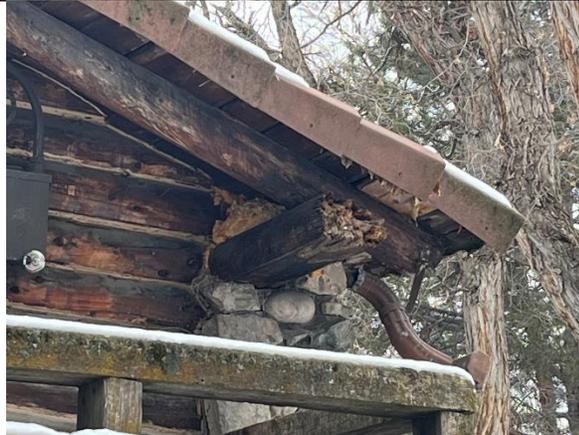
1.A.3

ITEM	DEFICIENCIES	PHOTOS	SHORT-TERM REPAIRS (0-5 Years)	LONG-TERM REPAIRS (25 Years)
1.A	Deteriorating logs at walls and roof eaves	1.A.1-3	Cover hole with EPDM membrane. Secure to sound logs.	Remove and replace deteriorating logs

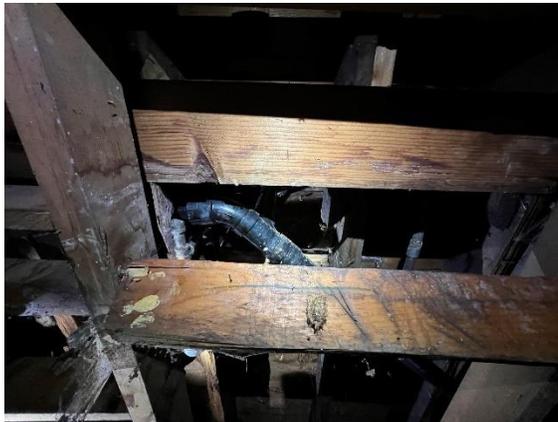
1.D	At east exterior stair, stringers not attached to landing	1.D.1	Restrict access to stairs	Positively attach stringers to landing framing
1.E	Wood floor joists cut and inadequately spliced below northeast bathroom	1.E.1-2	Restrict access to northeast bathroom	Sister new floor joists at existing spliced joists

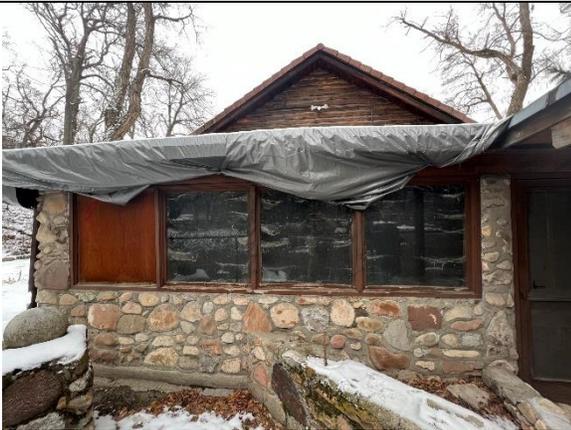
1.H	Roof collapsed at north addition	1.H.1	Restrict access to north addition	Remove and re-build collapsed roof with proper drainage
1.I	Top wall logs thrust off wall	1.I.1	Use tie rods to pull top wall logs back in line with log below	Add collar ties to roof purlins

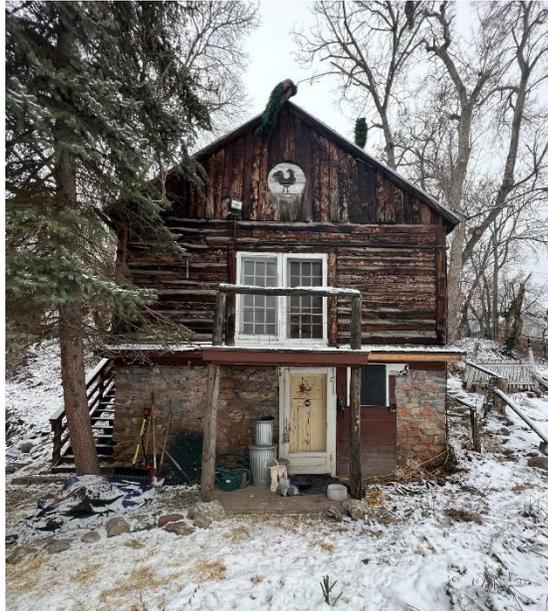
Figure 2: The Roost

- Two-story wood framed structure with log siding
- Stone foundation
- Straight roof and floor sheathing
- Overall rating - Fair

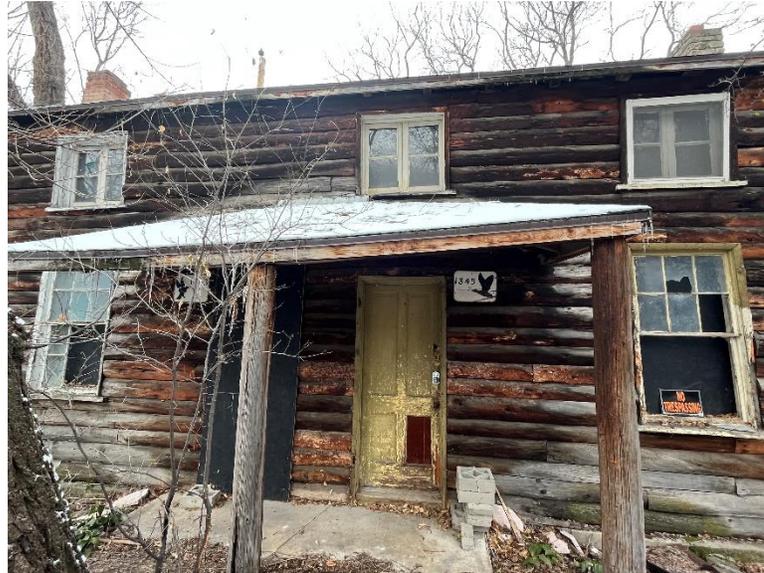
Figure 3: Thomas Boam House

- Two-story stacked log structure
- Concrete foundation
- Straight roof and floor sheathing
- Overall rating - Poor

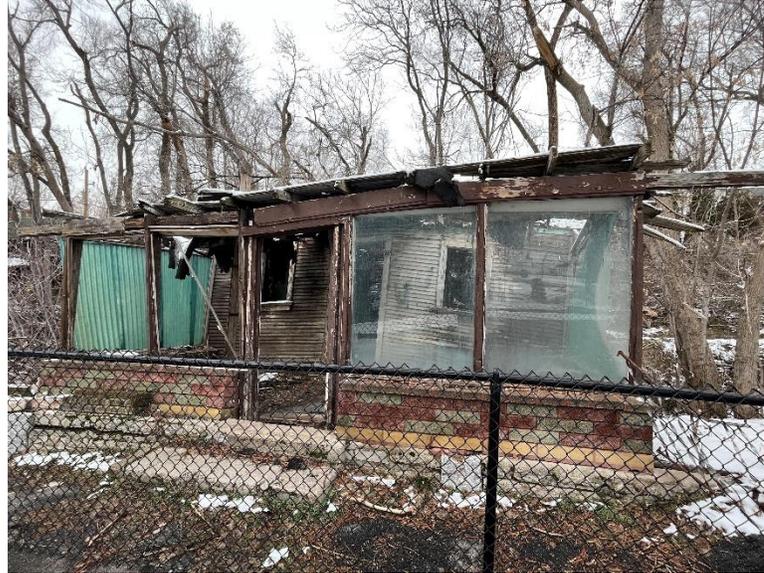
Figure 4: Aviary

- Single-story wood framed structure
- Wood post foundation
- Straight roof sheathing
- Overall rating - Poor

ITEM	DEFICIENCIES	PHOTOS	SHORT-TERM REPAIRS (0-5 YEARS)	LONG-TERM REPAIRS (25 YEARS)
4.A	Roof collapsed		Restrict access	Demo and rebuild if desired
4.B	Loss of building support in ravine		Restrict access	Demo and rebuild if desired

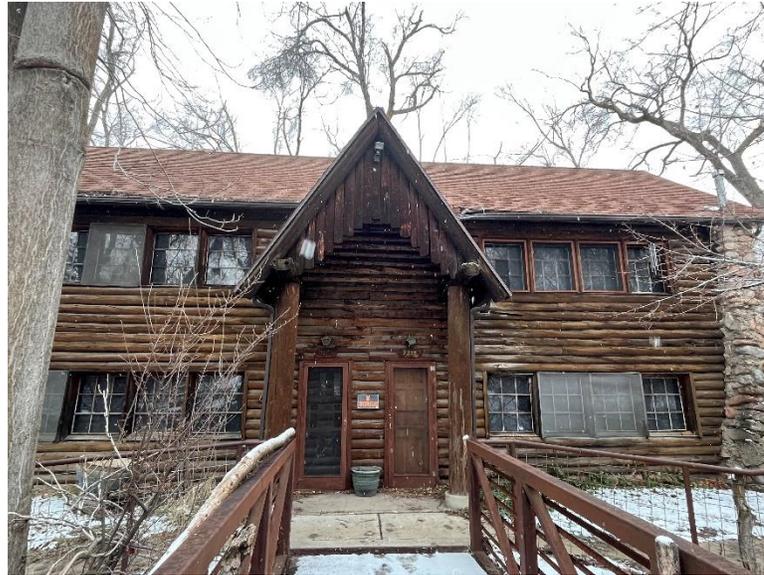
Figure 5: Ye Olde George Albert

- Two-story stacked log structure
- Concrete foundation
- Straight roof and floor sheathing
- Overall rating - Fair

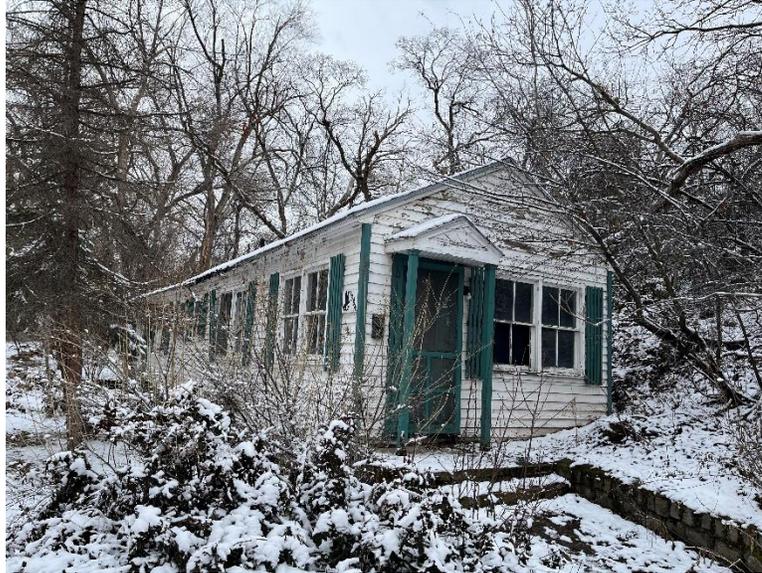
Figure 6: Duplex 1384-1386

- Single-story wood framed structure
- Unreinforced masonry foundation
- Straight roof sheathing
- Overall rating - Fair

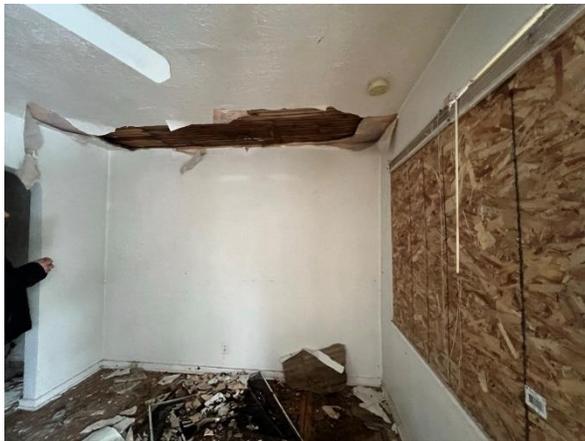
6.A.3-4

ITEM	DEFICIENCIES	PHOTOS	SHORT-TERM REPAIRS (0-5 YEARS)	LONG-TERM REPAIRS (25 YEARS)
6.A	Ceiling collapsed in some areas	6.A.1-4	N/A	Remove and replace water damaged ceiling framing
6.B	Deteriorating roof fascia boards and truss tails	6.B.1-2	N/A	Remove and replace deteriorating fascia boards and truss tails
6.C	Roof shingles are damaged and exceed their life span		Install ½" plywood sheathing over existing shingles and SBS self-adhering granule-surfaced modified-bitumen rolled roofing membrane	Install plywood sheathing, underlayment, ice and water shield and historically appropriate shingles
6.D	Unreinforced masonry foundation walls		N/A	Install structural reinforced shotcrete wall at unreinforced masonry foundation walls

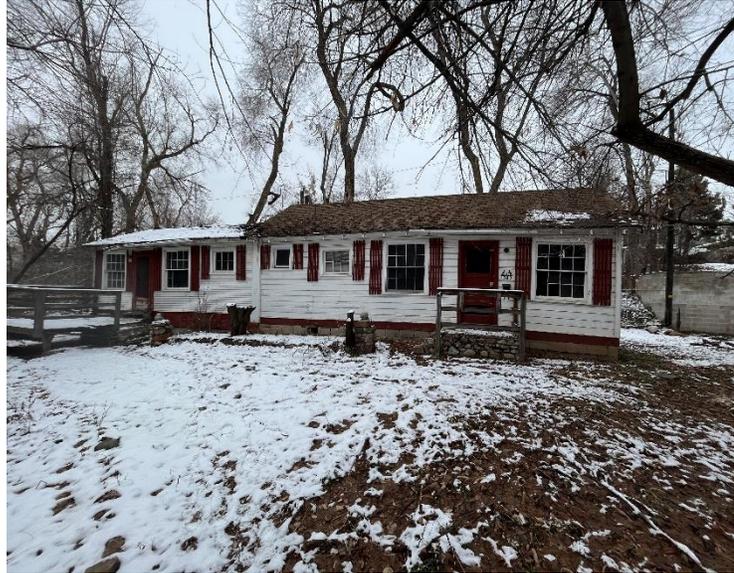
Figure 7: Duplex 1387-1389

- Single-story wood framed structure.
- Unreinforced masonry foundation
- Straight roof sheathing
- Overall rating - Poor

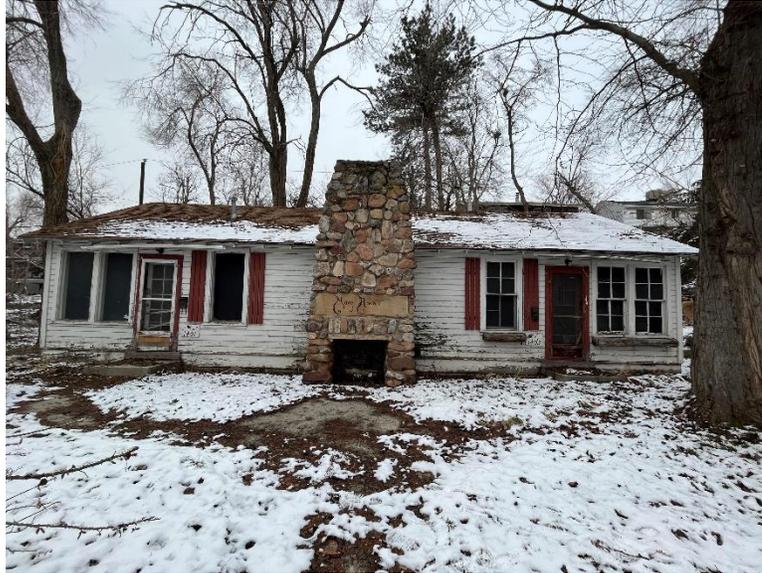
Figure 8: The Mary Rose

- Single-story wood framed structure
- Concrete foundation
- Straight roof sheathing
- Overall rating - Fair

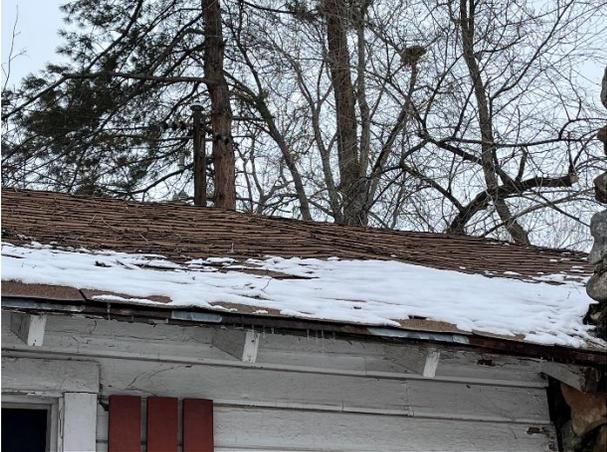
8.C.1

ITEM	DEFICIENCIES	PHOTOS	SHORT-TERM REPAIRS (0-5 YEARS)	LONG-TERM REPAIRS (25 YEARS)
8.A	Ceiling collapsed in some areas		N/A	Remove and replace water damaged ceiling framing
8.B	Deterioration of siding near chimney	8.B.1	N/A	Remove and replace deteriorating siding and wall framing
8.C	Roof shingles are damaged and exceed their life span		Install ½" plywood sheathing over existing shingles and SBS self-adhering granule-surfaced modified-bitumen rolled roofing membrane	Install plywood sheathing, underlayment, ice and water shield and historically appropriate shingles

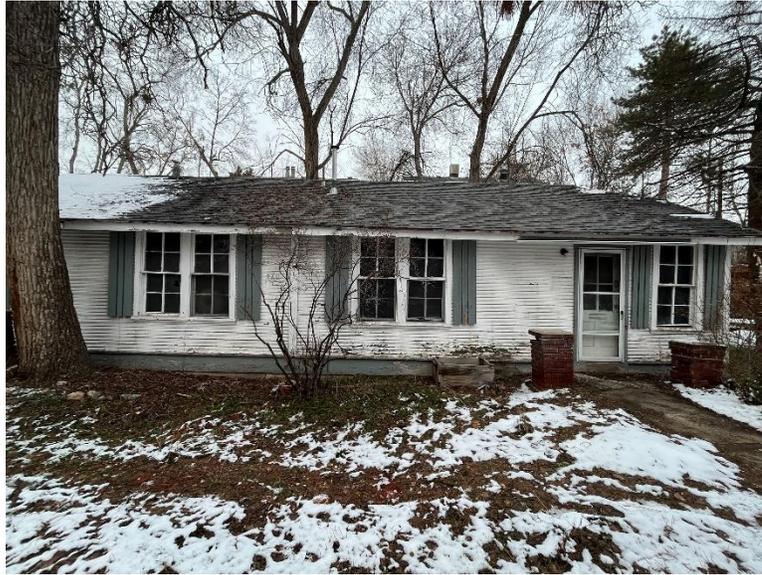
Figure 9: The Roberta

- Single-story wood framed structure
- Concrete foundation
- Straight roof sheathing
- Overall rating - Good

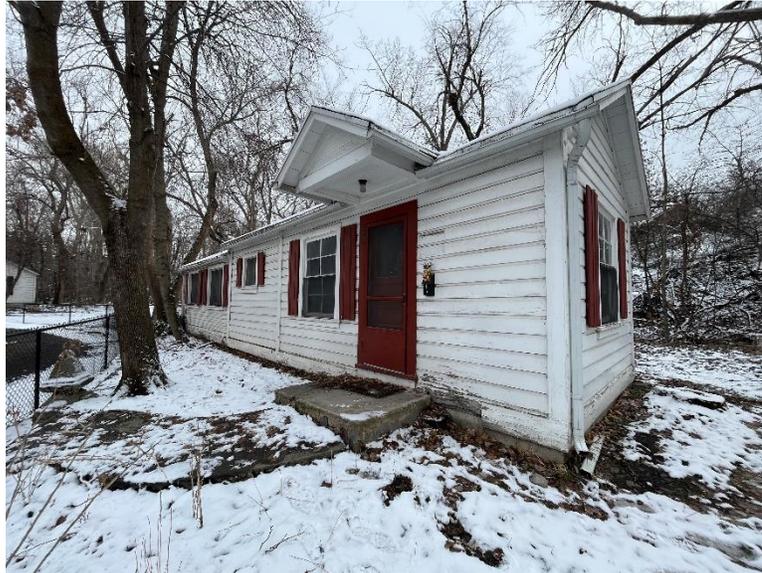
Figure 10: Duplex 1414

- Single-story wood framed structure
- Concrete foundation
- Straight roof sheathing
- Overall rating - Fair

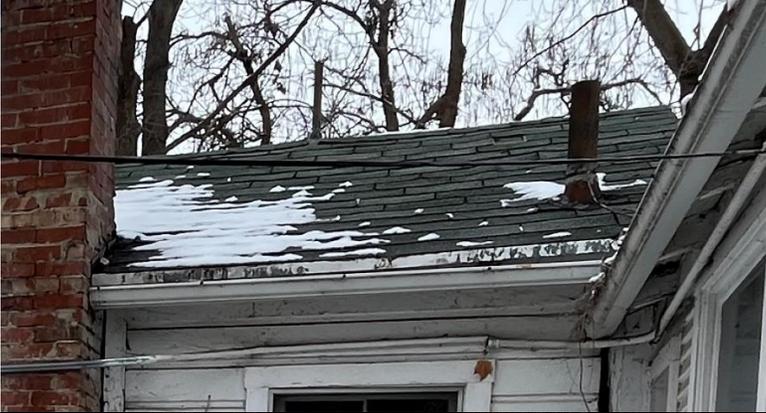
ITEM	DEFICIENCIES	PHOTOS	SHORT-TERM REPAIRS (0-5 YEARS)	LONG-TERM REPAIRS (25 YEARS)
10.A	Ceiling collapsed in some areas		N/A	Remove and replace water damaged ceiling framing
10.B	Deteriorating roof fascia boards	10.B.1	N/A	Remove and replace deteriorating fascia boards
10.C	Roof shingles are damaged and exceed their life span	10.C.1	Install ½” plywood sheathing over existing shingles and SBS self-adhering granule-surfaced modified-bitumen rolled roofing membrane	Install plywood sheathing, underlayment, ice and water shield and historically appropriate shingles
10.D	Foundation settlement		N/A	Shore foundation walls using micropiles or helical piers

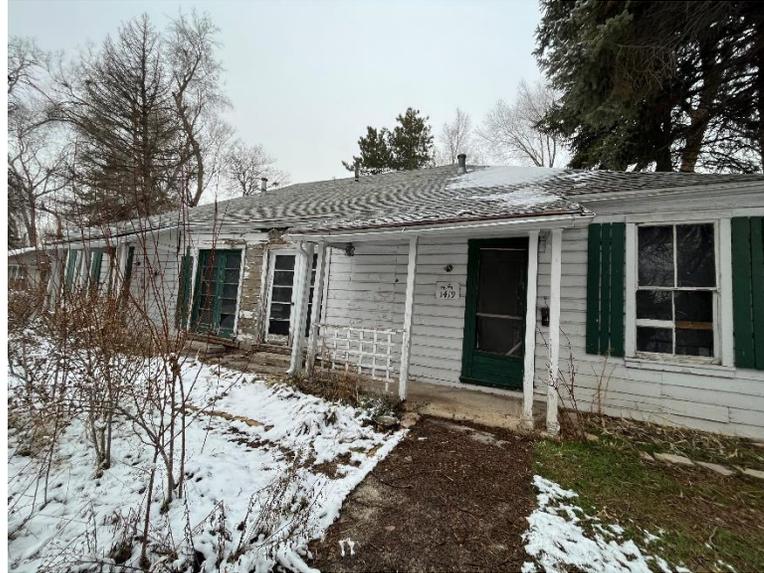
Figure 11: The Sally Ann

- Single-story wood framed structure
- Concrete foundation
- Straight roof sheathing
- Overall rating - Fair

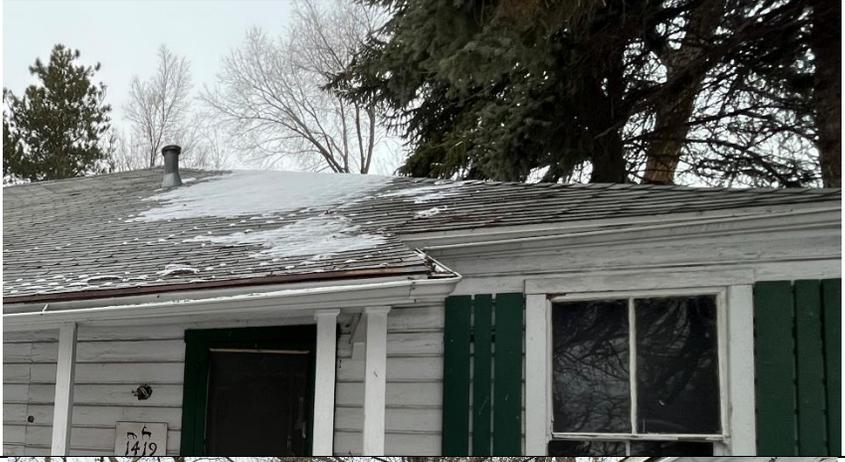
ITEM	DEFICIENCIES	PHOTOS	SHORT-TERM REPAIRS (0-5 YEARS)	LONG-TERM REPAIRS (25 YEARS)
11.A	Ceiling collapsed in some areas		N/A	Remove and replace water damaged ceiling framing
11.B	Deteriorating roof fascia boards	11.B.1	N/A	Remove and replace deteriorating fascia boards
11.C	Roof shingles are damaged and exceed their life span	11.C.1	Install ½" plywood sheathing over existing shingles and SBS self-adhering granule-surfaced modified-bitumen rolled roofing membrane	Install plywood sheathing, underlayment, ice and water shield and historically appropriate shingles
11.D	Canopy framing is pulling away from main structure	11.D.1	N/A	Positively attach canopy framing to main structure

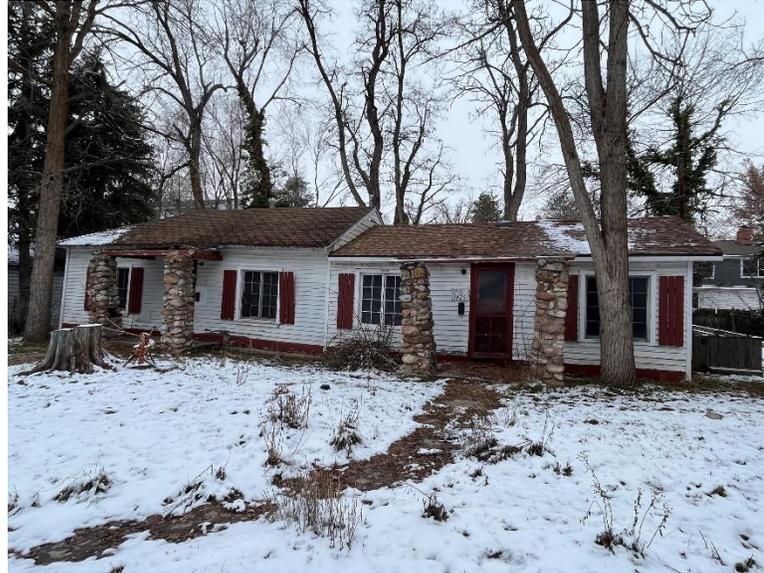
Figure 12: Duplex 1423-1425

- Single-story wood framed structure
- Concrete foundation
- Straight roof sheathing
- Overall rating - Fair

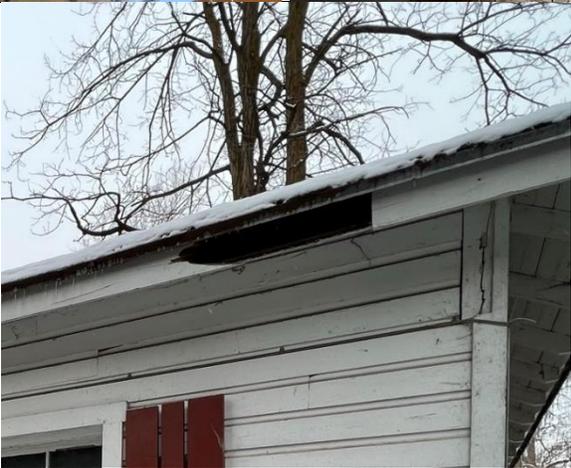
ITEM	DEFICIENCIES	PHOTOS	SHORT-TERM REPAIRS (0-5 YEARS)	LONG-TERM REPAIRS (25 YEARS)
12.A	Ceiling collapsed in some areas	12.A.1-2	N/A	Remove and replace water damaged ceiling framing
12.B	Deteriorating roof fascia boards	12.B.1	N/A	Remove and replace deteriorating fascia boards
12.C	Roof shingles are damaged and exceed their life span	12.C.1	Install ½" plywood sheathing over existing shingles and SBS self-adhering granule-surfaced modified-bitumen rolled roofing membrane	Install plywood sheathing, underlayment, ice and water shield and historically appropriate shingles
12.D	Deterioration at canopy framing	12.D.1-2	N/A	Remove and replace deteriorating canopy framing
12.E	Settlement at canopy stone columns	12.E.1	N/A	Shore and straighten stone columns

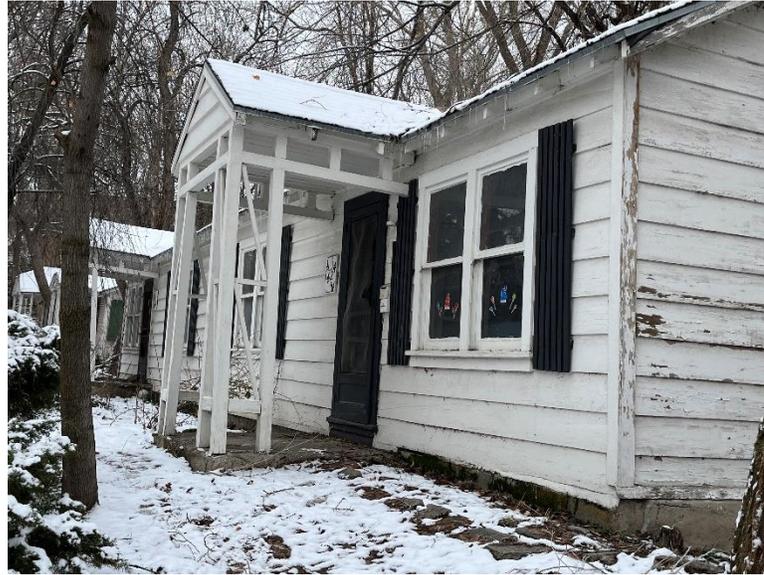
Figure 13: Duplex 1424-1426

- Single-story wood framed structure
- Concrete foundation
- Straight roof sheathing
- Overall rating - Fair

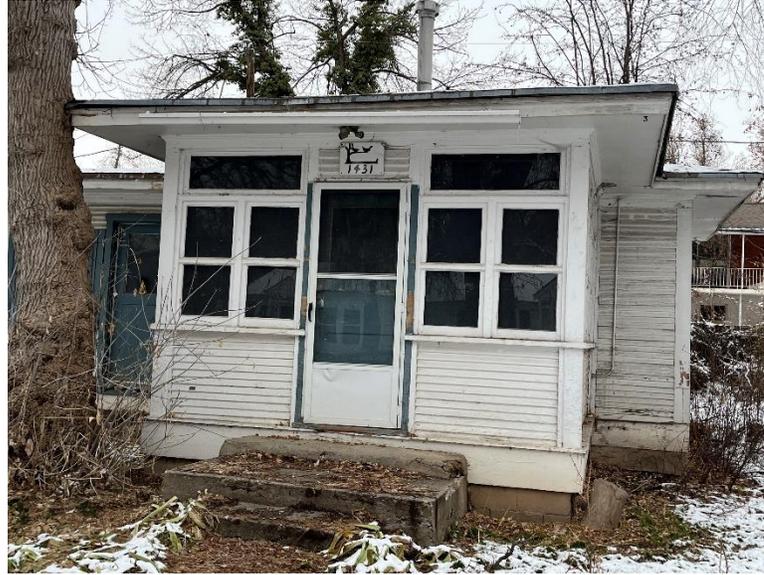
Figure 14: Ethylene

- Single-story wood framed structure
- Unreinforced masonry foundation
- Straight roof sheathing
- Overall rating - Poor

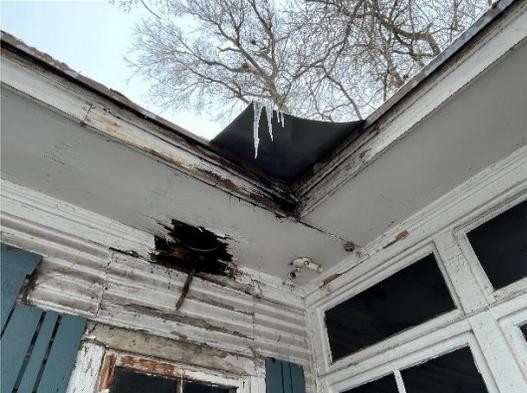
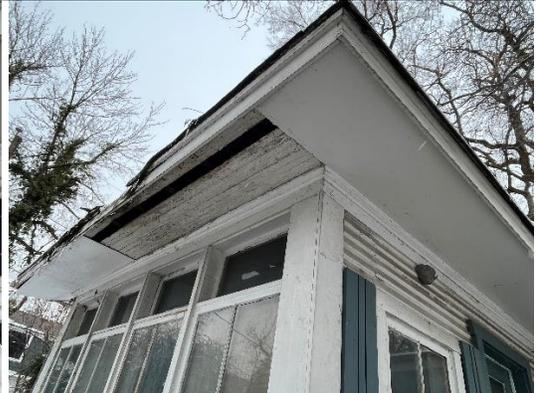
14.D	Deteriorating roof fascia boards	14.D.1-2	N/A	Remove and replace deteriorating fascia boards
14.E	Tree growing against canopy framing	14.E.1	N/A	Remove tree

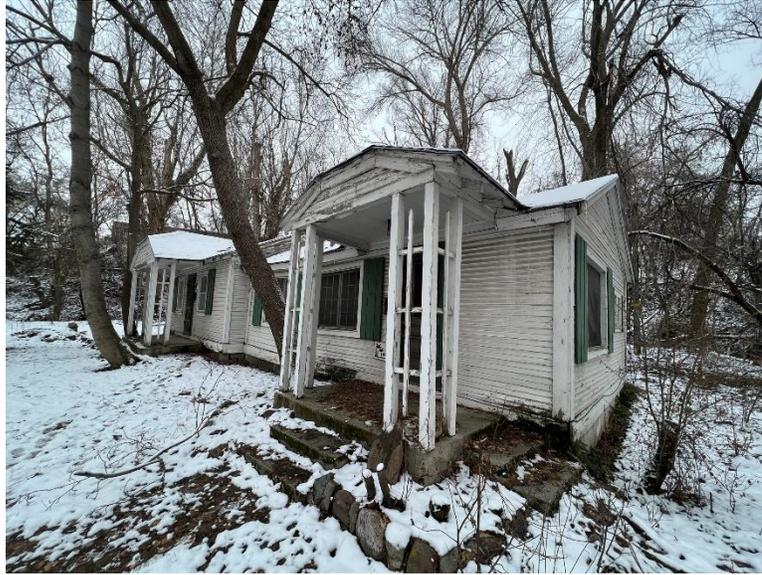
Figure 15: Duplex 1434-1436

- Single-story wood framed structure
- Unreinforced masonry foundation
- Straight roof sheathing
- Overall rating - Poor
